SAMPLE INSPECTION REPORT

PROPERTY INSPECTION REPORT

Type of building: Single family

Age of building: Built in 2000 (as per MLS listing)

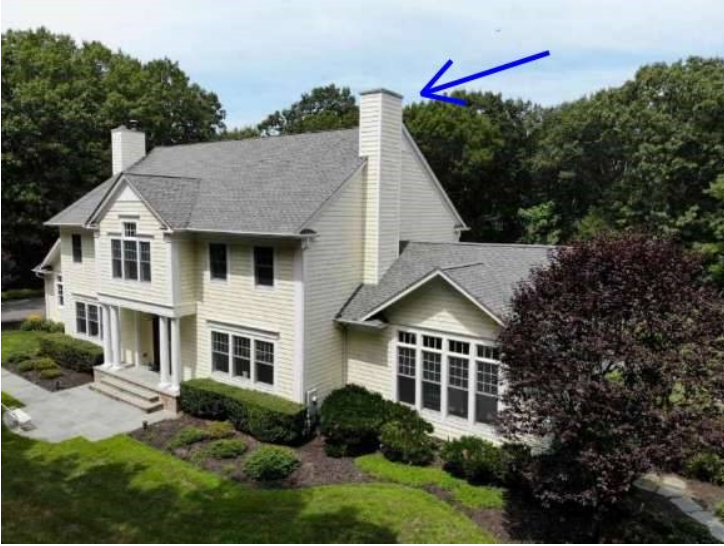
The home has two (2) chimney structures. Blue arrow indicates the chimney which does not appear to serve any wood-burning and/or gas fireplace, as well as any appliances requiring ventilation. Inspector was unable to determine the purpose nor find any vents associated with secondary chimney. Client should inquire with property owner about the intended purpose of this

secondary chimney.

Photo 2-2 No vent on secondary chimney.

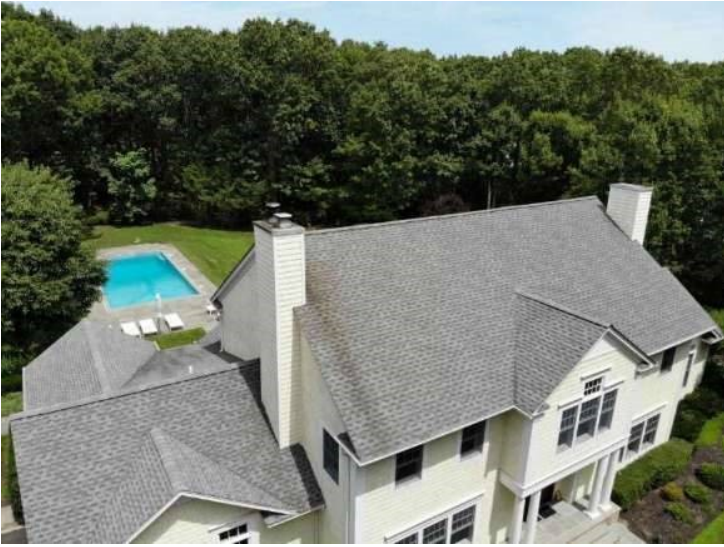
Photo 3-1

One or more composition shingles are damaged and/or deteriorated and should be replaced. Leaks may occur as a result. In addition, there are one or more areas of staining on the roof, which may be the result of rust from the chimney flue and an accumulation of moss build-up. A qualified roofing contractor should evaluate and make repairs as necessary.

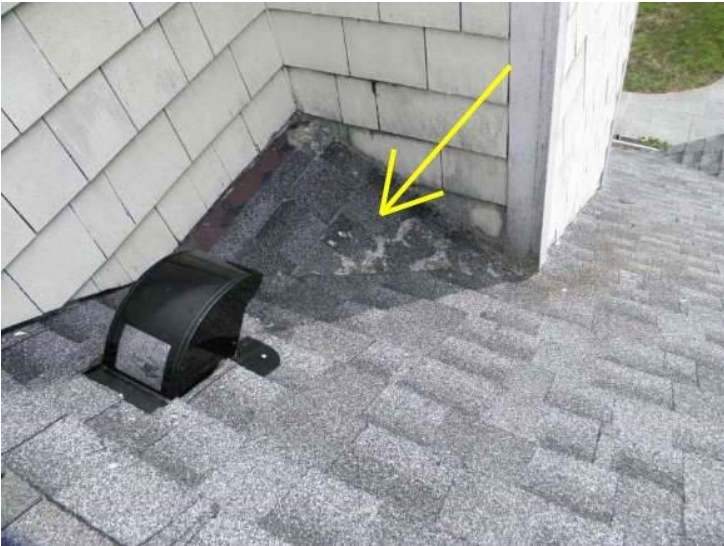
Photo 3-3 Area where possible leaks may occur.

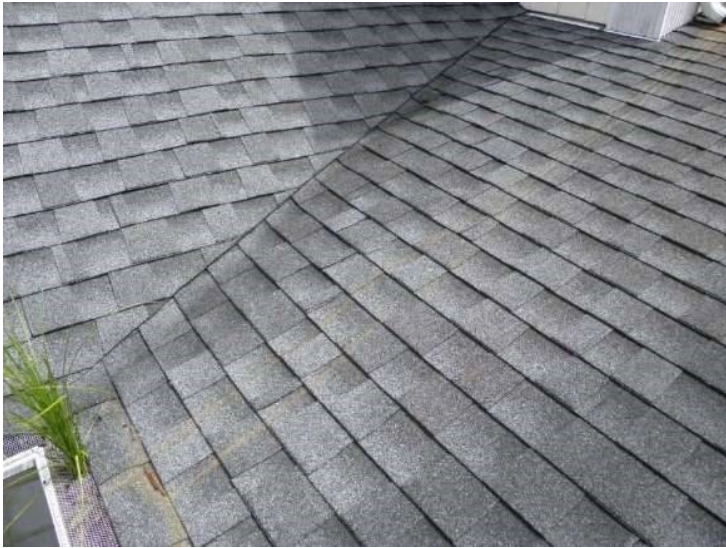
Photo 4-1

Debris has accumulated in one or more gutters. This is a conducive condition for wood destroying insects since gutters may overflow and cause water to come in contact with the structure's

exterior or make water accumulate around the foundation. Gutters should be cleaned now and as necessary in the future.

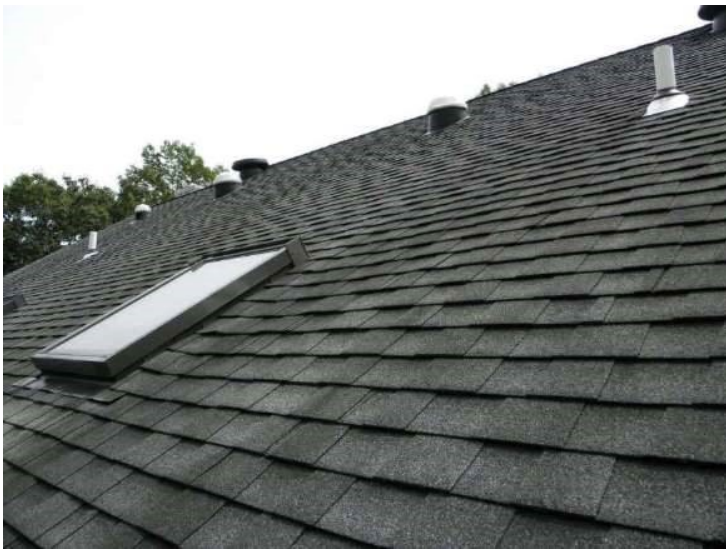
Photo 5-1

Moss is growing on the roof. As a result, shingles may lift or be damaged. Leaks may result and/or the roof surface may fail prematurely. This is a conducive condition for wood destroying insects and organisms. Efforts should be taken to kill the moss during its growing season (wet months). Typically zinc-based chemicals are used for this, and must be applied periodically. For information on various moss treatment products and their pros and cons, visit <http://bryophytes.science.oregonstate.edu/page24.htm>

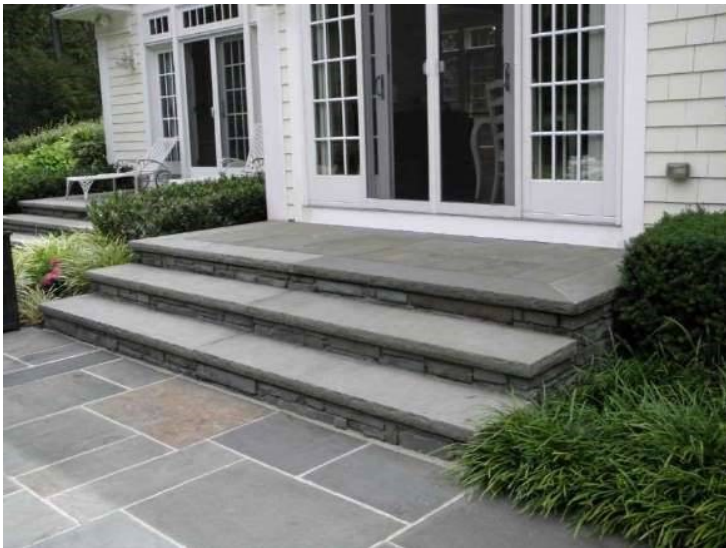
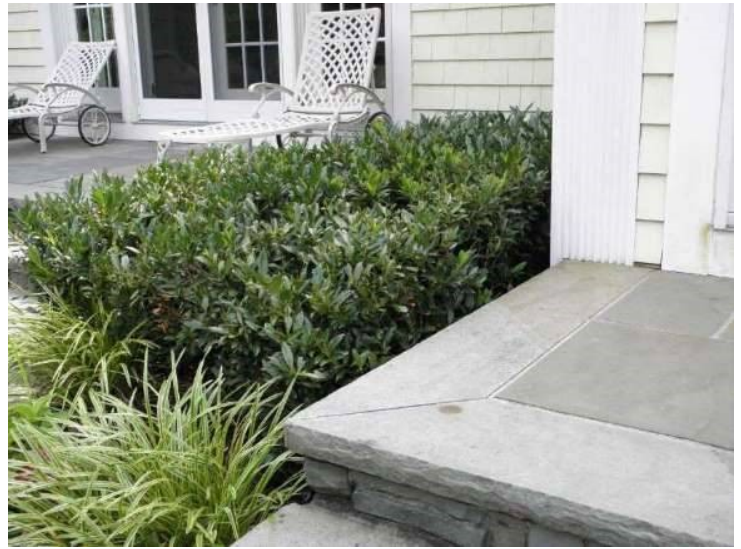
It is advisable to install handrails/guardrails where missing from sections of patio and/or elevated surfaces to reduce safety hazard due to the risk of falling. A qualified contractor should evaluate and install handrails/guardrails, as necessary and as per standard building practices.

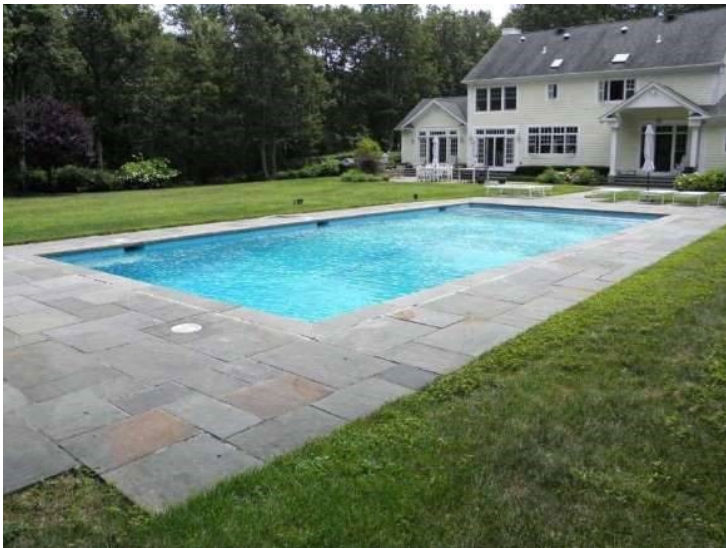
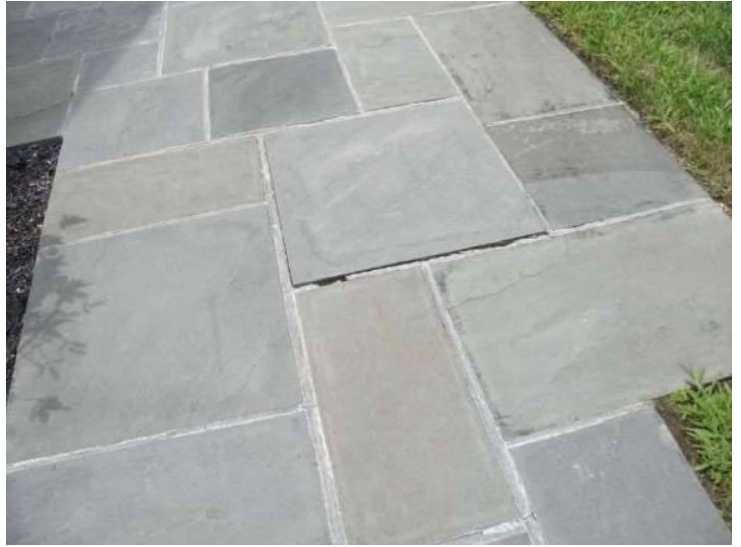
Several sections of blue stone surrounding pool and property have lifted, loose and/or damaged stones. These sections pose potential tripping hazards. A qualified contractor should evaluate and prescribe repairs and perform required maintenance, as needed.

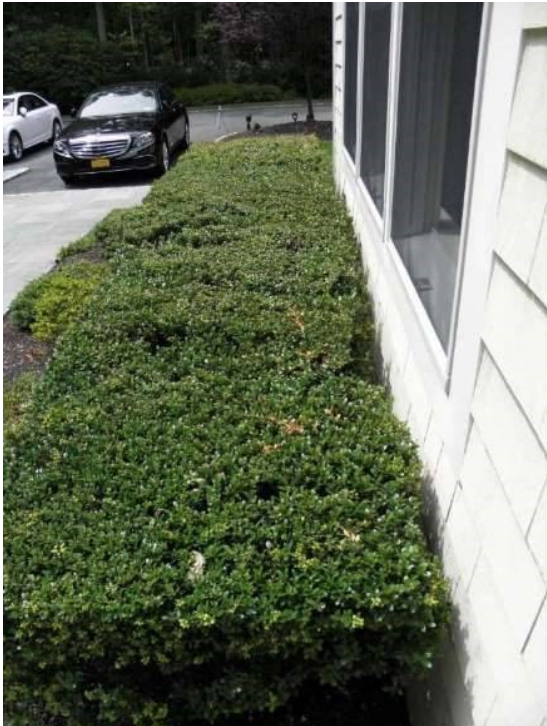
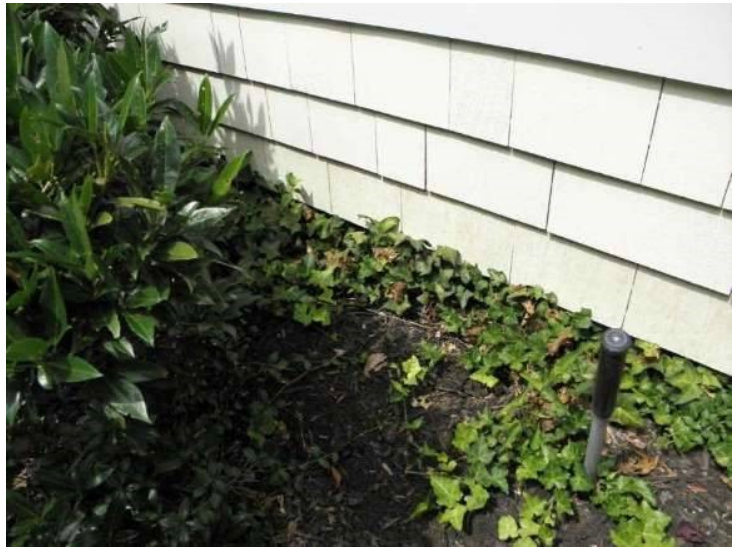
8) + Vegetation such as trees, shrubs and/or vines are in contact with or less than one foot from the structure's exterior. Vegetation can serve as a conduit for wood destroying insects and may retain moisture against the exterior after it rains. Vegetation should be pruned and/or removed as necessary to maintain a one foot clearance between it and the structure's exterior.

Furthermore, one or more sections of foundation and/or exterior walls are excluded from this inspection due to lack of access from vegetation and/or stored items.

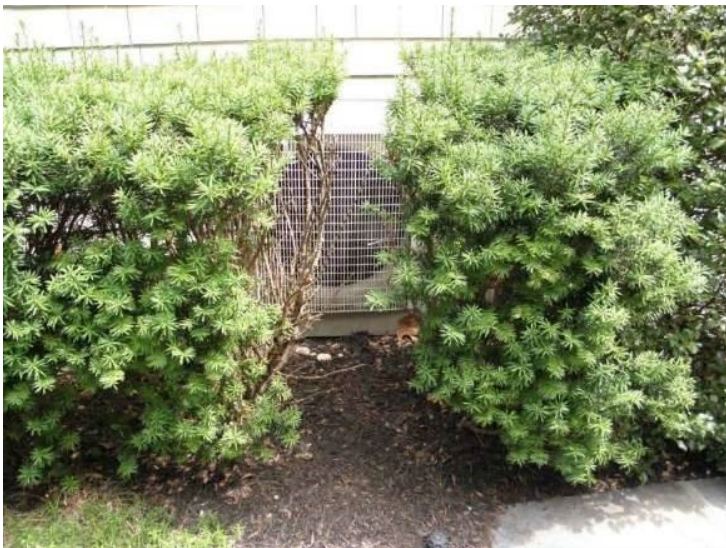
Photo 8-7 Vegetation is obstructing proper ventilation for air conditioning condenser and should be cleared.

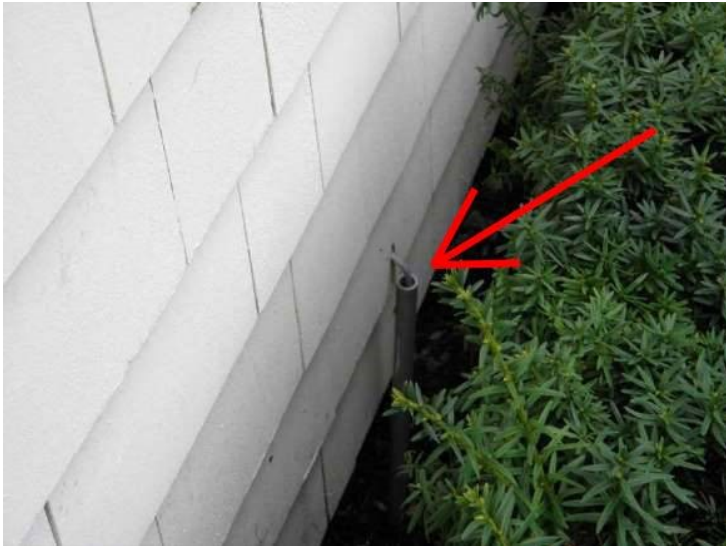
Photo 9-1

An exterior electrical wire is not properly nor completely encased in the wire casing (where indicated by red arrow). This is a potential safety hazard due to risk of shock. Modifications/repairs should be made as necessary and as per standard building practices.

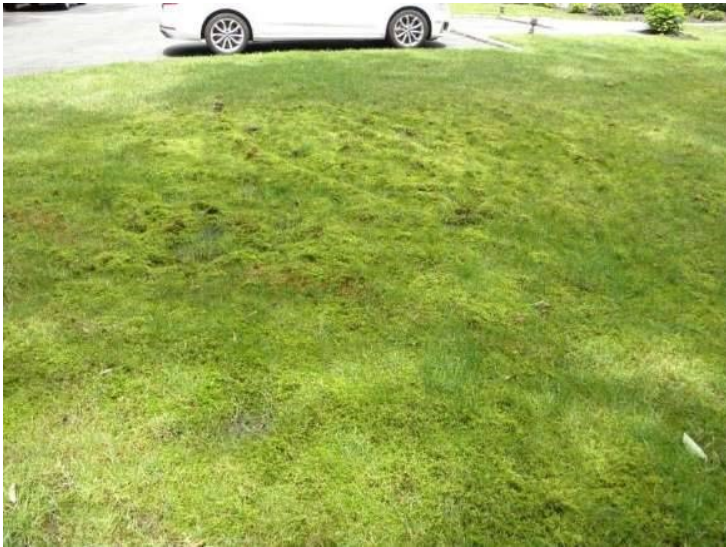
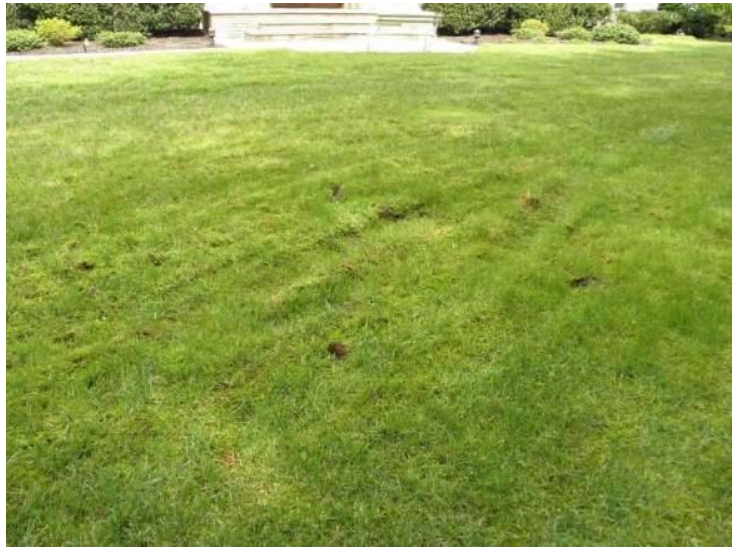
One or more areas of the grounds around the structure have significantly soggy soil and/or indications of accumulated water at times (sediment, dead grass, etc.). Client should consult property owner to determine the cause of these areas being saturated and unable to be traversed without sinking into soil. Further recommend consulting with a qualified contractor who specializes in drainage, to determine if or what repairs are needed to provide adequate drainage. Possible repairs may involve grading soil, or installing, repairing and/or replacing underground drains.

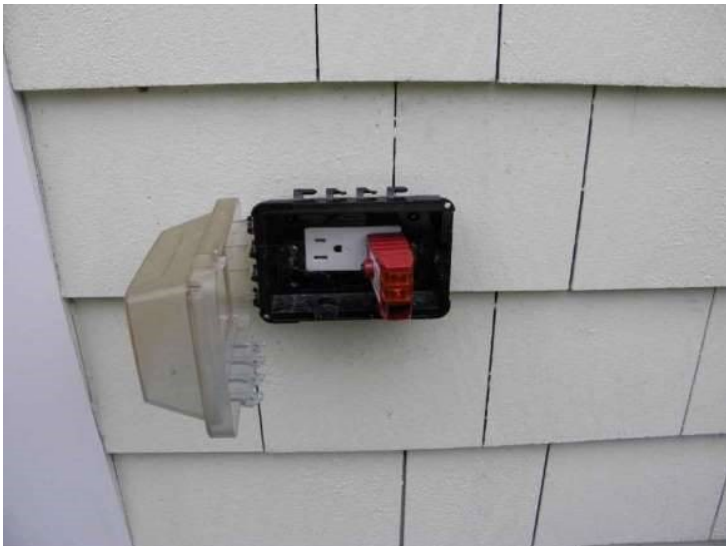
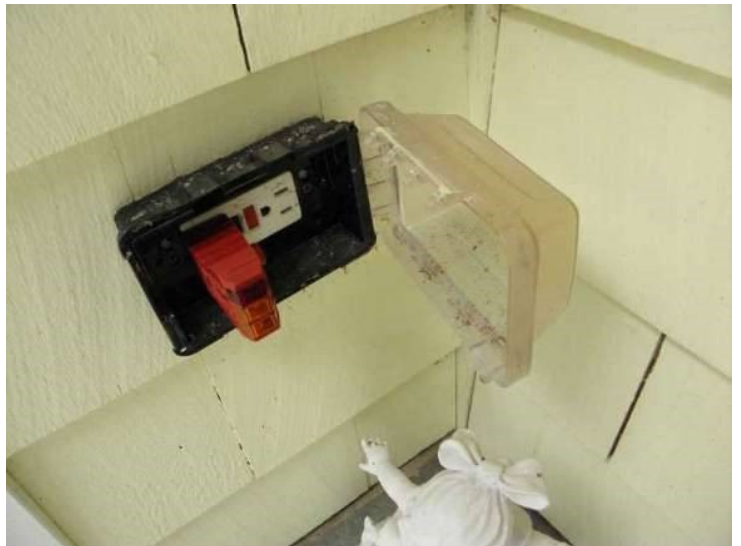
11) 🔧🔍 One or more outdoor electric receptacles appear to have no power. Recommend asking the property owner about this. Switches may need to be operated to make some receptacles energized. If necessary, a qualified electrician should evaluate and make repairs as necessary.

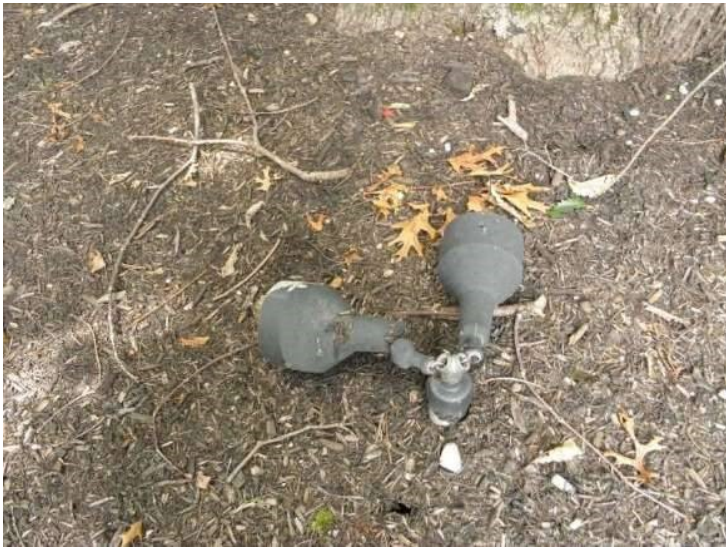
Photo 12-1

12) 🔧🔍 One or more light fixtures are damaged and/or deteriorated. A qualified electrician should evaluate and repair or replace light fixtures where necessary.

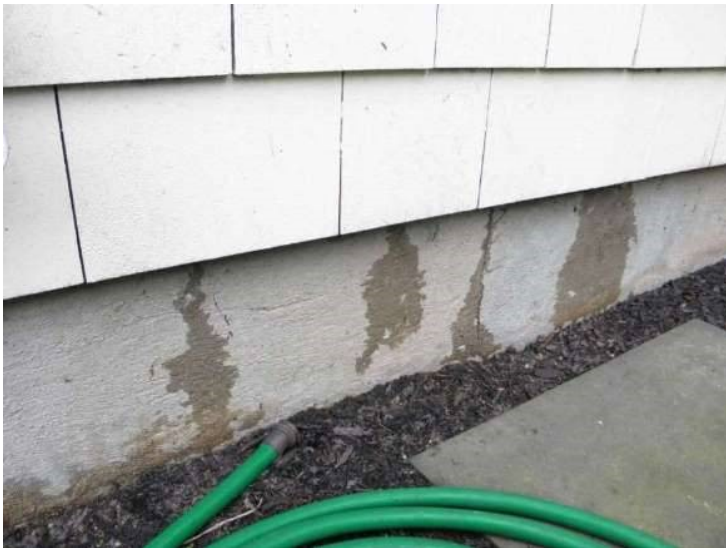
Photo 13-1

Upon testing the outdoor faucet spigot, inspector found water leaking from beneath one or more areas of wood shingles. This appears to be the result of a defective/damaged water pipe. A qualified plumber should evaluate and repair, as necessary and as per standard building practices.

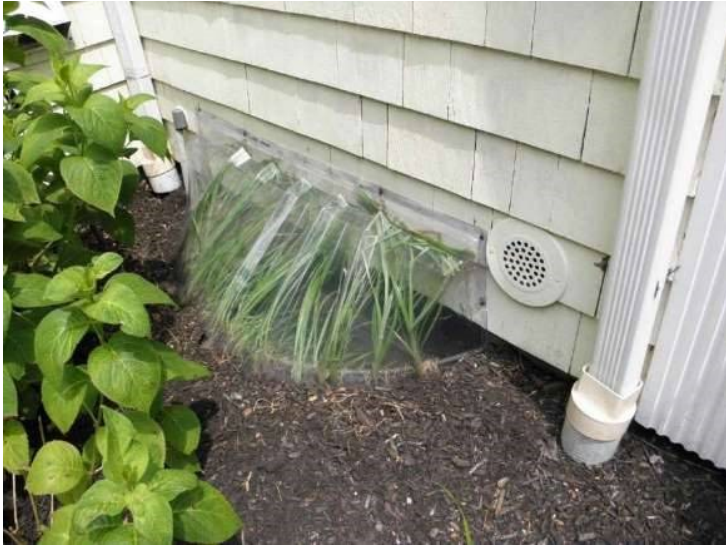
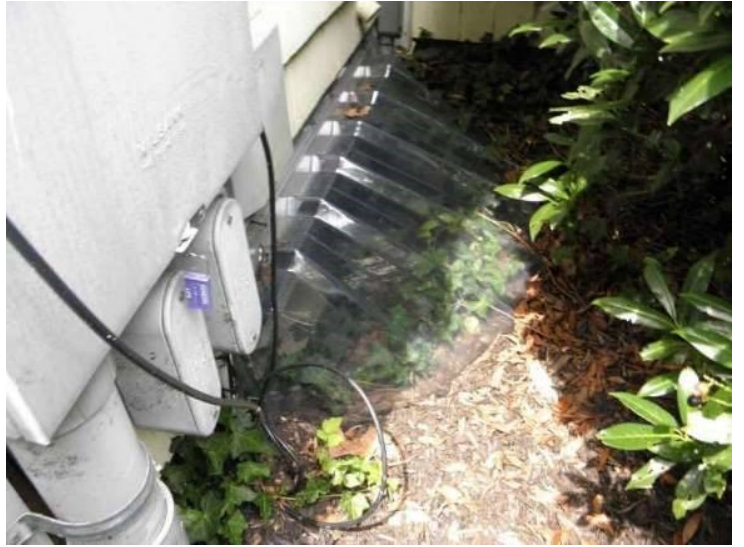
Basement window dome covers are not properly placed and not properly secured. As a result, the dome covers may potentially be ineffective at keeping rain water from entering basement. A qualified contractor should evaluate and make necessary repairs/modifications as per standard building practices.

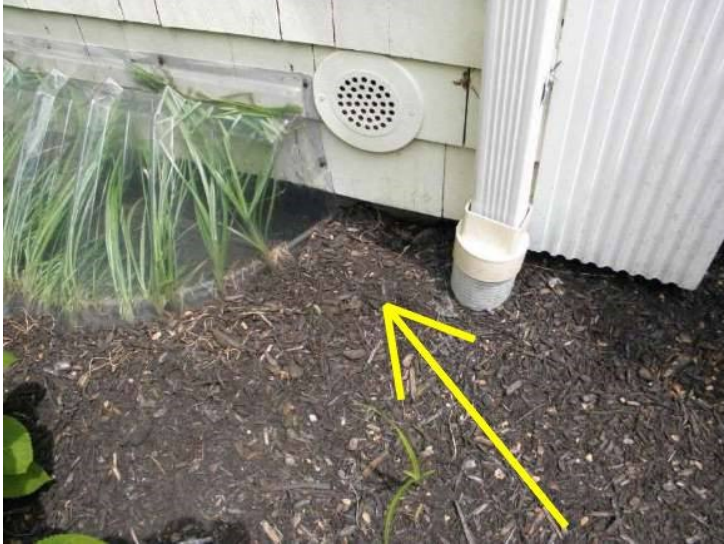
Photo 15-1

The perimeter grading slopes towards the structure in one or more areas. This can result in water accumulating around the structure's foundation, basement and crawl space. Accumulated

water is a conducive condition to wood destroying insects and organisms. Wet soil may also cause the foundation to settle and possibly fail over time. Recommend grading soil so it slopes down and away from the structure with a slope of at least 5% (10% or better is optimal) for at least 6 feet.

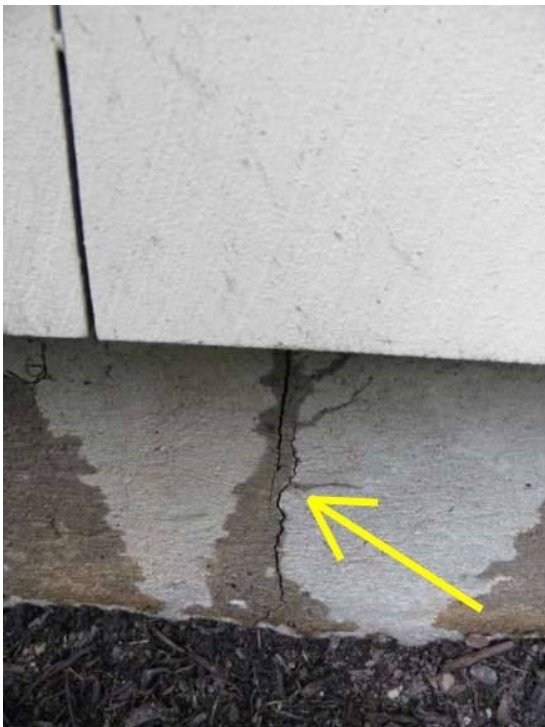
Photo 16-1

A crack was found in the foundation, which may be a structural concern or an indication that settlement is ongoing. Client should have this area, as well as other areas concealed by brush and vegetation, further evaluated by a qualified contractor to determine if settlement is ongoing, what the cause of the settlement is, to ensure no other cracks are present, and to prescribe any necessary repairs.

At a minimum, recommend sealing cracks to prevent water infiltration. Numerous products exist to seal such cracks including:

- Hydraulic cement. Requires chiseling a channel in the crack to apply. See <https://www.reporhost.com/?HYDCEM> for an example.
- Resilient caulks (easy to apply). See <https://www.reporhost.com/?RESCAULK> for an example.
- Epoxy sealants (both a waterproof and structural repair). See <https://www.reporhost.com/?EPXSEAL> for examples of these products.

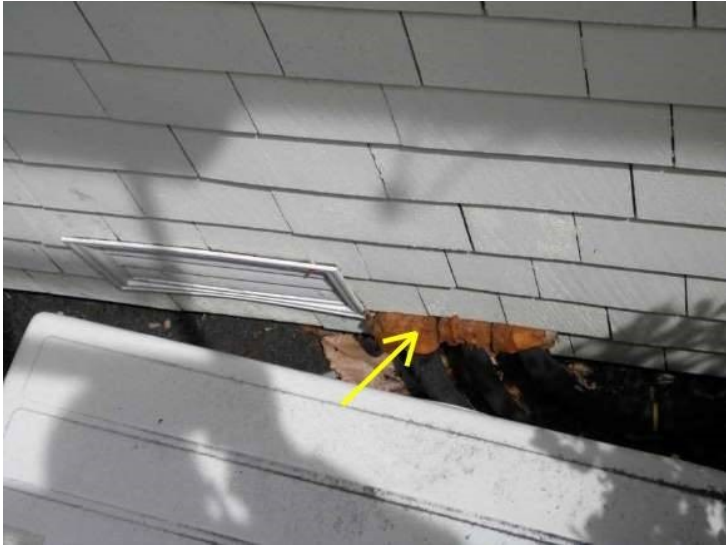
Photo 17-1

Area surrounding crawl space vent should be cleared, as it appears to currently restrict ventilation which may result in increased levels of moisture inside.

In addition, the insulation (where indicated by yellow arrow) is substandard. A qualified contractor should evaluate and make necessary repairs/modifications as per standard building practices and to prevent water infiltration.

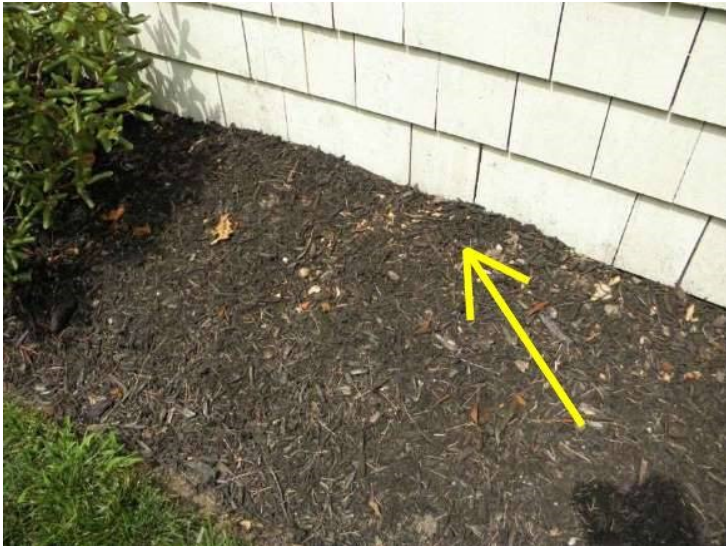
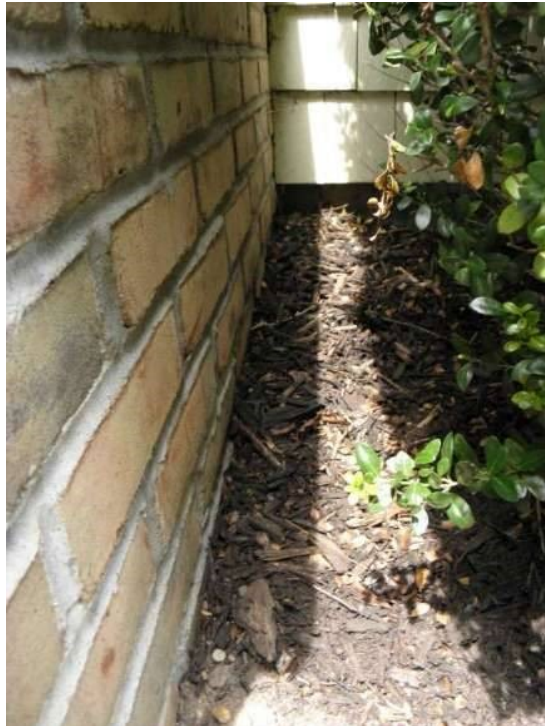
18) 🐜 Soil is in contact with or less than six inches from siding and/or trim. This is a conducive condition for wood destroying insects and organisms. Soil should be graded and/or removed as necessary so there are at least six inches of space between the siding and trim and the soil below.

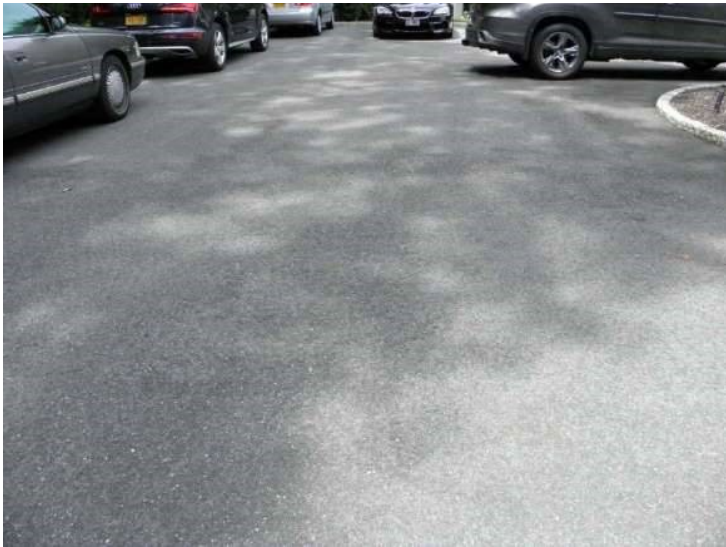
Photo 19-1

19) 🛠️ Recommend resealing asphalt driveway.

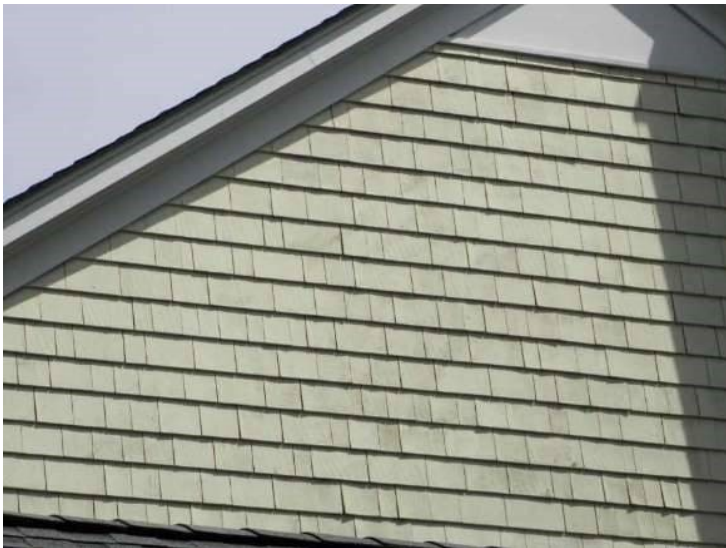
Photo 20-1

20) There are one or more loose wood shingles and areas where the wood shingle exterior finish is failing. A qualified contractor should prep (pressure wash, scrape, sand, prime, caulk, etc.) and repaint/re-caulk areas, as needed and as per standard building practices.

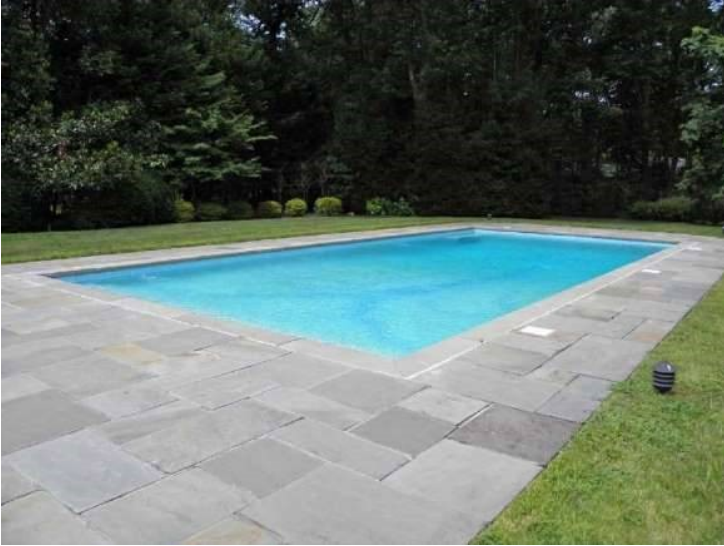
The Gunite pool appears to be in overall good condition. However, inspector noted a few areas of potential concern and/or inquires which should be made with property owner:

1. There appears to be minor deterioration to the pool tiles. Client should verify when pool surfaces were last refinished. Recommend having pool further evaluated by a qualified pool technician and maintenance/repairs performed as needed.

2. Inspector was unable to locate the ground rod. Ground rods are a necessary safety item to prevent risk of shock and damage to pool equipment. Client should inquire with property owner to determine the location of the ground rod.

3. The filter pressure gauge appears to be inoperable. A qualified pool technician should evaluate and make necessary repairs/modifications.

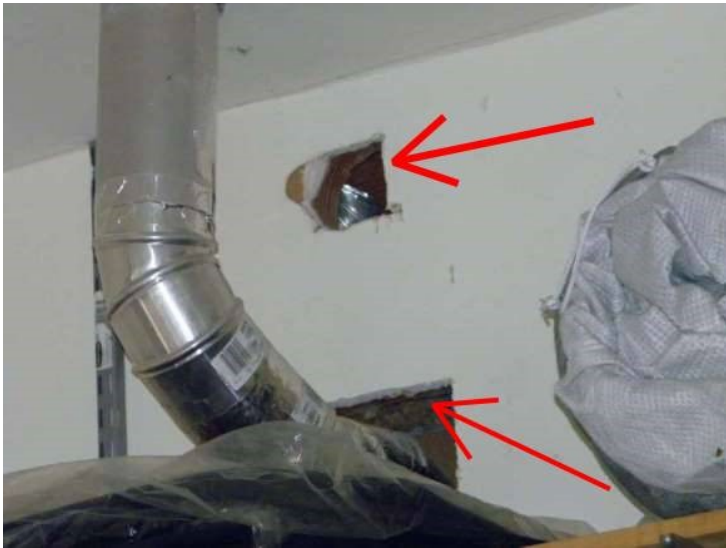
Photo 24-1

24) One or more wall and/or ceiling surfaces between the attached garage and interior living spaces have gaps, holes, and/or missing or inadequate surface materials. These surfaces are intended to prevent vehicle fumes from entering living spaces and to slow the spread of fire from the garage to living spaces. A qualified contractor should evaluate and make repairs as necessary so the attached garage wall and ceiling surfaces that adjoin living spaces are tightly sealed and fire rated as per standard building practices. Typically these surfaces require a one-hour fire rating.

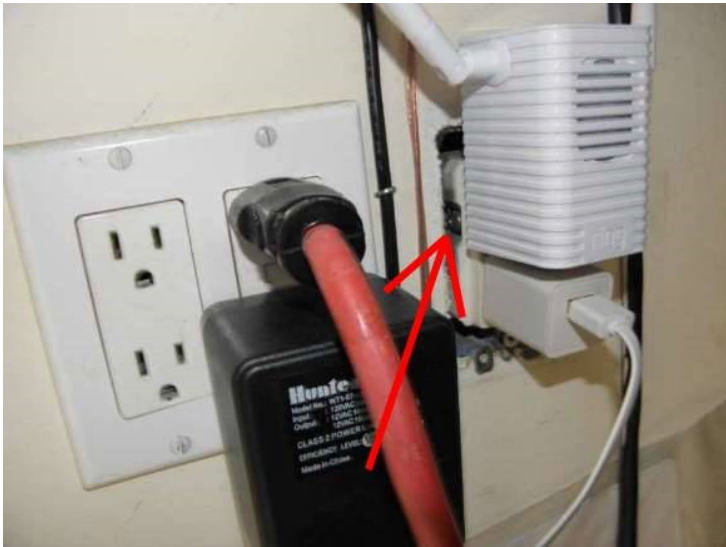
Photo 27-1

A cover plate is missing from the electric receptacle pictured below. Cover plates are intended to contain fire and prevent electric shock from exposed wires. This is a safety hazard due to the risk of fire and shock. The cover plate should be installed where missing.

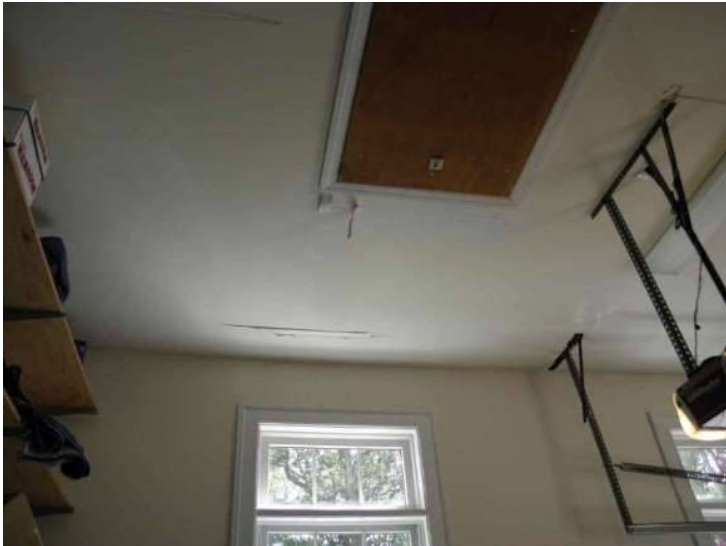
Photo 28-1

28) 🗝️ The garage ceiling surrounding the attic hatch is stained and deteriorated. This appears to be the result of an active or previous roof leak. Upon confirming that there are no active roof leaks, repairs should be made to the garage ceiling, as necessary and as per standard building practices.

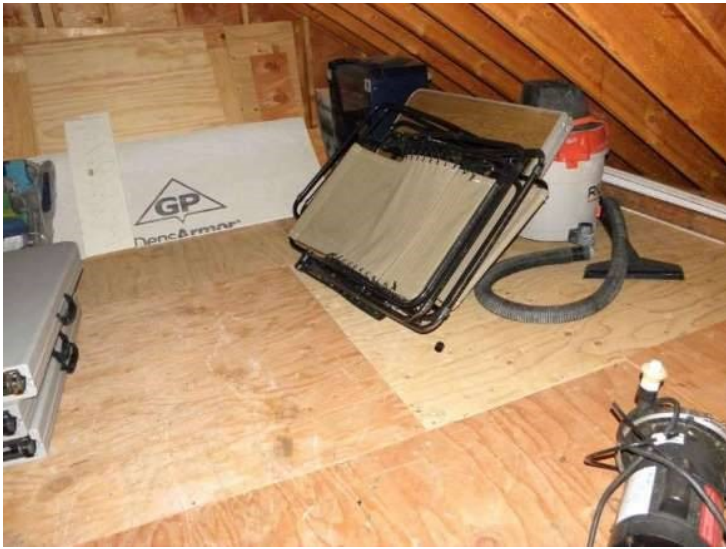
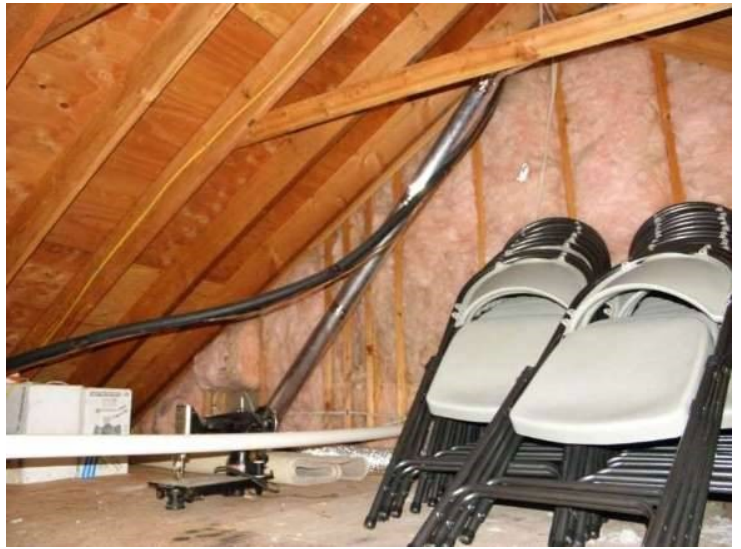
29) 🔍 Several areas of the attic could not be fully evaluated due to excessive stored items. As a result, inspector was unable to determine if the air handler (indicated by the blue arrow) is active, operable or disconnected. A qualified contractor should evaluate and determine what, if any, repairs/modifications are needed as per standard building practices.

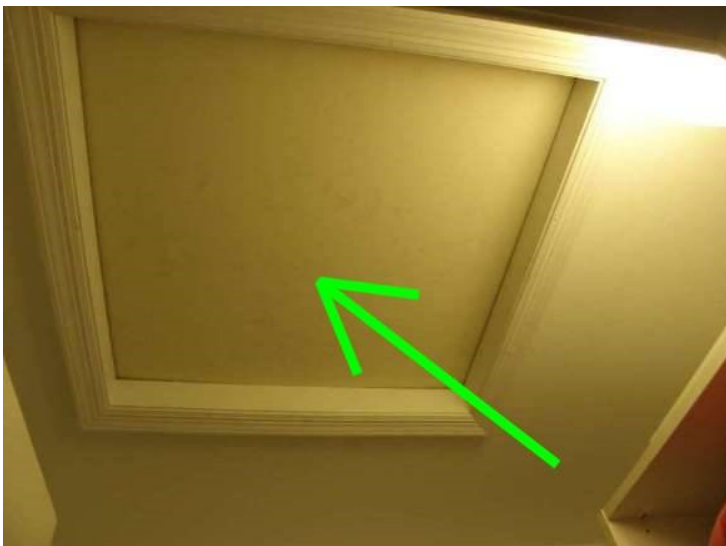
Photo 30-1

No insulation is installed over the attic access hatch. Recommend installing insulation above hatch for better energy efficiency.

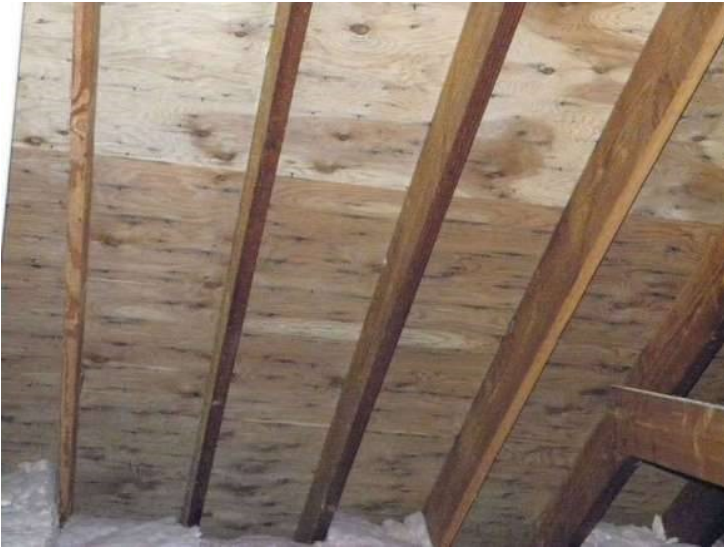
Photo 31-1

Stains were visible on the roof structure in one or more areas. These areas were dry at the time of the inspection. The stains may be caused by an active or past leak. Recommend asking the property owner about past leaks. The client should monitor these areas in the future, especially after heavy rains, to determine if active leaks exist. If leaks are found, a qualified roofing contractor should evaluate and repair as necessary.

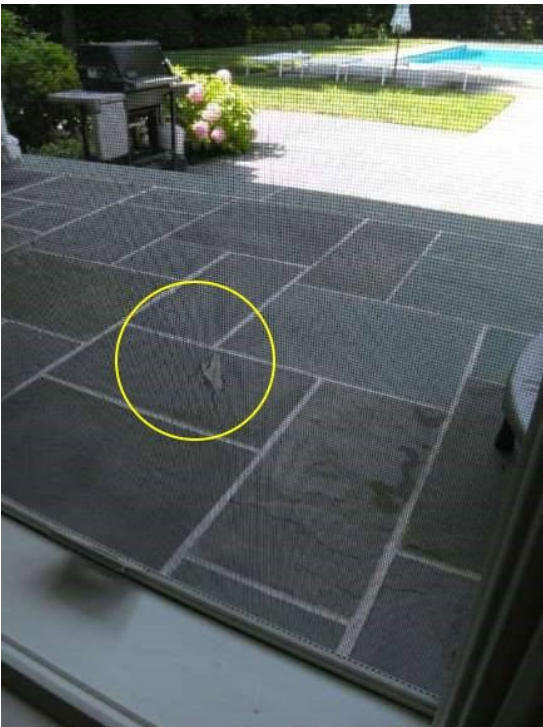
Photo 32-1

The rear window screen is torn and should be replaced as necessary.

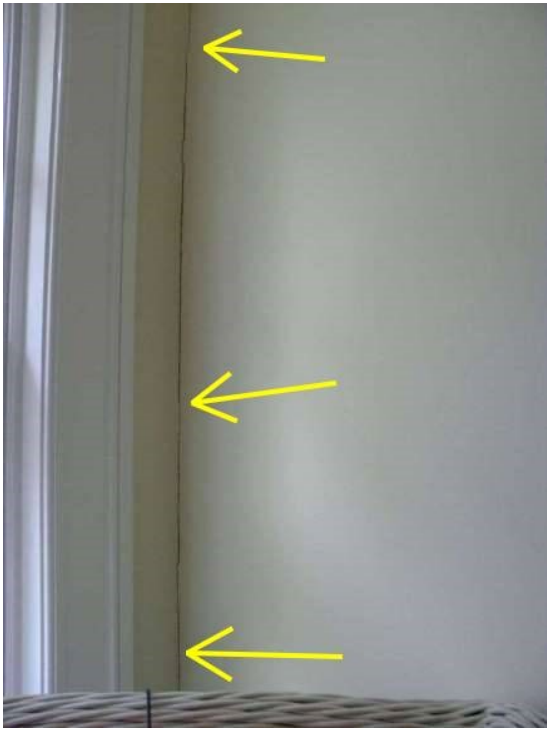
Photo 33-1

Minor cracks were found in walls in one or more areas of the upper-level bedrooms. Client may wish to have these areas further evaluated by a qualified contractor to determine the cause, i.e., possible settlement and have any necessary repairs made.

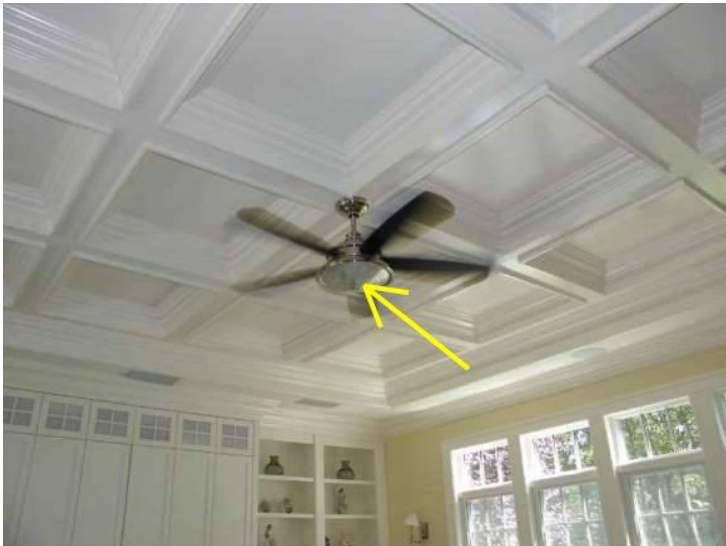
Photo 34-1

The living space ceiling fan light is inoperable. Recommend further evaluation by replacing bulb and/or consulting with the property owner. Repairs or replacement of the light fixture by a qualified electrician may be necessary.

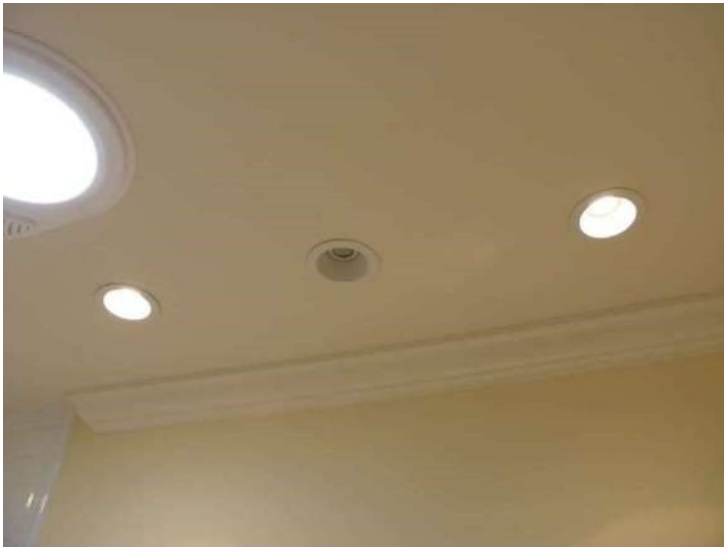
Photo 35-1

One or more ceiling light fixtures appear to be inoperable. Recommend further evaluation by replacing bulbs and/or consulting with the property owner. Repairs or replacement of the light fixtures by a qualified electrician may be necessary.

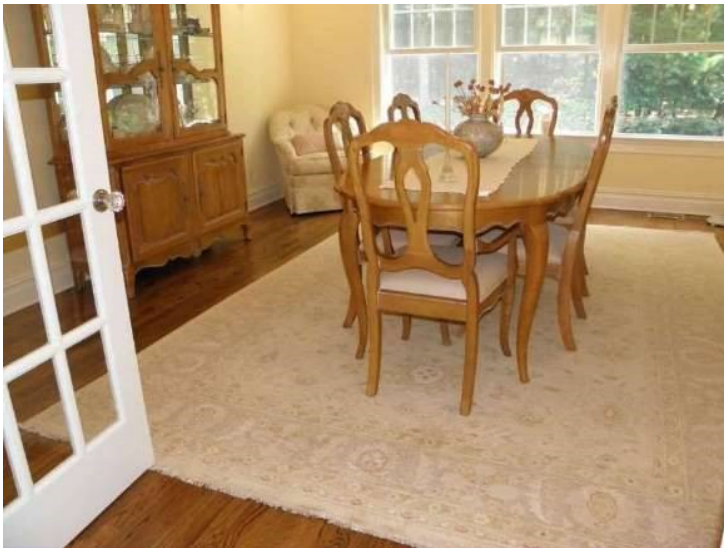
Photo 36-1

One or more floor joists may be undersized for their span. Sagging and/or bouncing floors may result. Additional floor joists and/or support columns may be necessary. A qualified contractor should evaluate and make repairs/modifications as necessary.

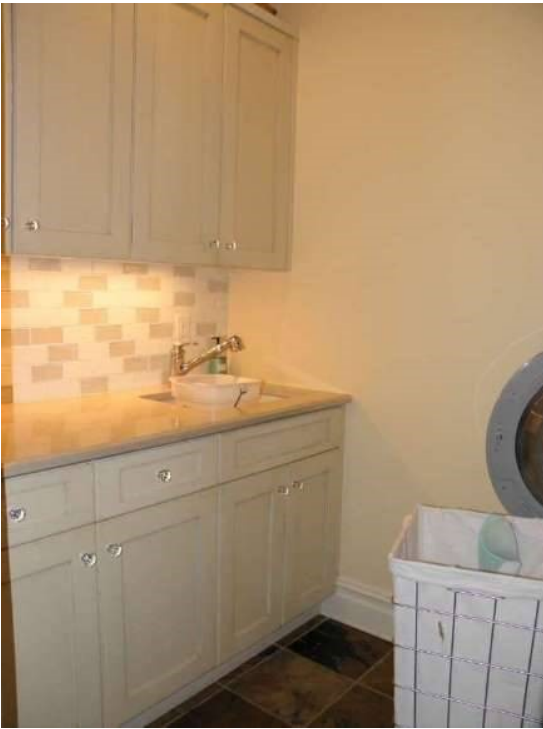
Photo 39-1

39) **i** The cabinets located in the laundry room have one or more areas of wear and deterioration.

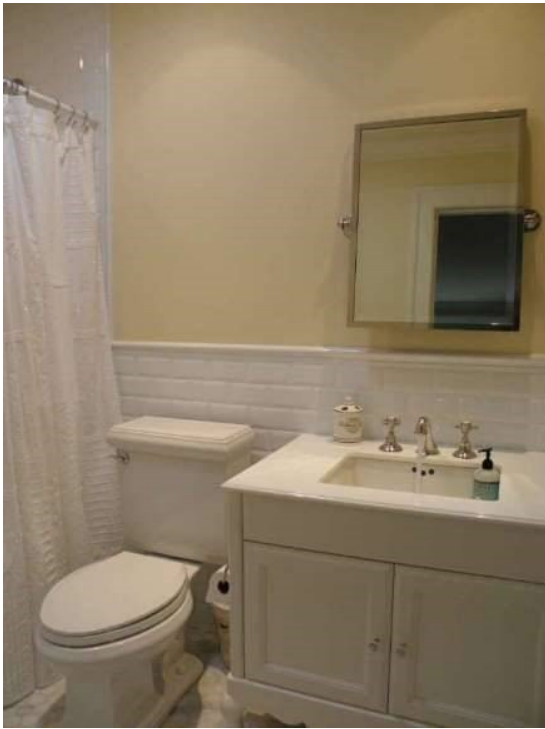
Photo 41-1

The upper-level bathroom electric receptacle had no power at the time of inspection. Recommend asking the property owner about this. Switches may need to be operated to make some receptacles energized. If necessary, a qualified electrician should evaluate and make repairs as necessary.

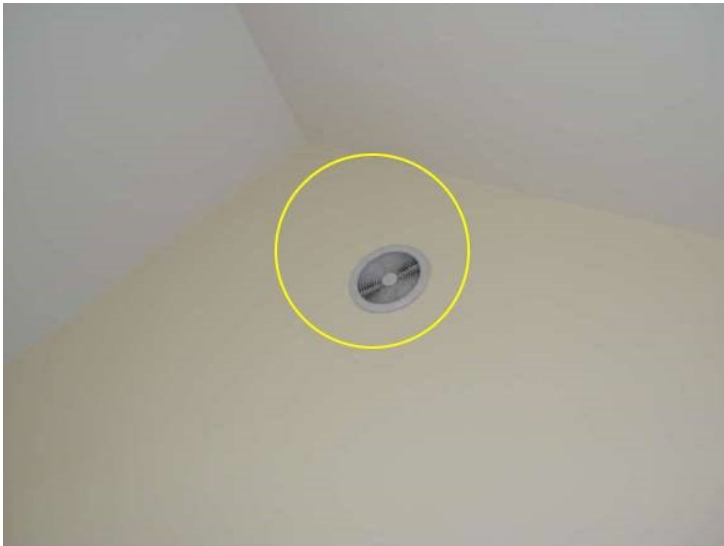
Photo 42-1

One or more exhaust fans in the upper-level bathrooms are inoperable or provide inadequate air flow. Moisture may accumulate as a result. A qualified contractor should evaluate and repair or replace exhaust fans, as necessary.

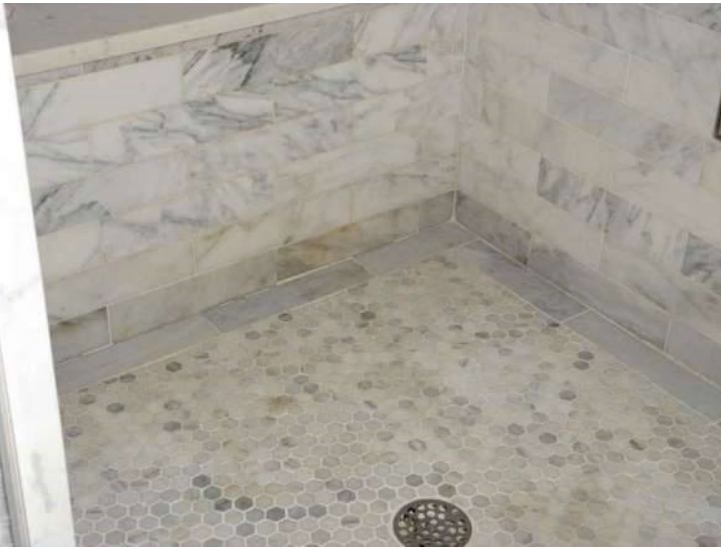
Photo 43-1

Grout in one or more showers is discolored and/or missing. A qualified contractor should evaluate and replace grout, as necessary.

In addition, there is staining at the base of one or more showers (where indicated by blue circles). This staining appears to be the result of standing/pooling water that did not properly drain. Client may wish to have these areas further evaluated by a qualified contractor and modifications made to prevent further discoloration and/or damage to the surrounding structure.

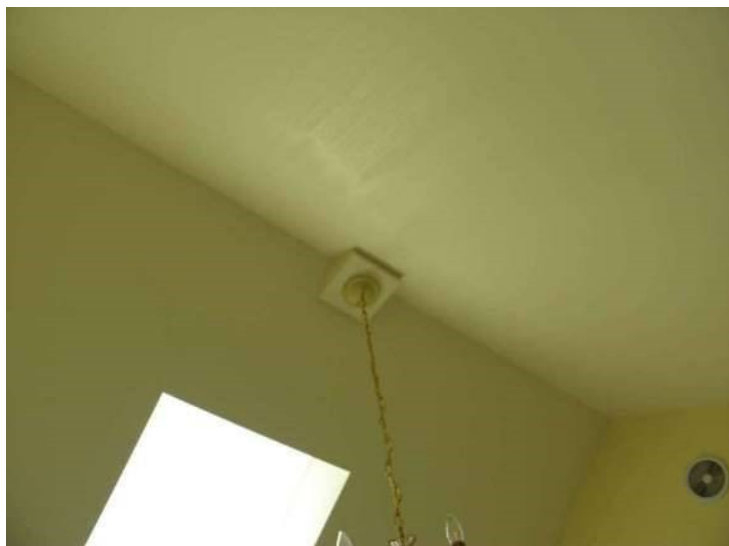
Photo 45-1

The bathroom ceiling and skylights show signs of moisture in one or more areas, as evidenced by stains and discoloration. This may be the result of an active or past leak or moisture build-up due to ineffective or inoperable exhaust fans. Further evaluation is recommended by a qualified contractor.

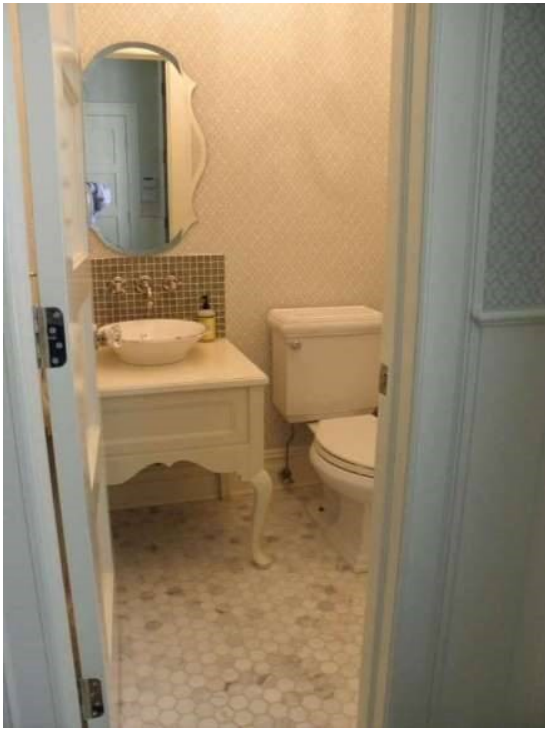
Photo 46-1

46) Lower-level half bath does not appear to have a source of heating or cooling.

In addition, there is minor deterioration to the sink countertop.

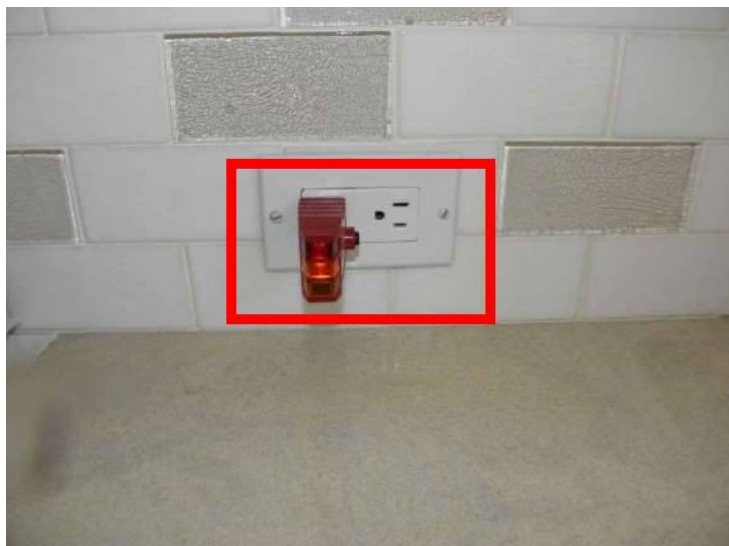
Photo 48-1

The kitchen counter electric receptacle has reverse-polarity wiring, where the hot and neutral wires are reversed. This is a safety hazard due to the risk of shock. A qualified electrician should evaluate and make repairs as necessary.
