SAMPLE INSPECTION REPORT

PROPERTY INSPECTION REPORT

Type of building: Single family

Age of building: Built in 2000 (as per MLS listing)

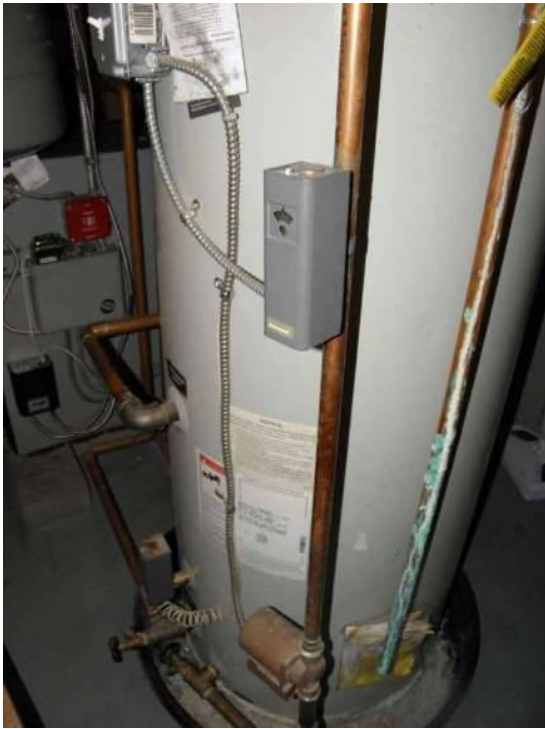
Photo 51-1

The estimated useful life for most water heaters is 8 to 12 years. This water heater appears to be exceeding this age and there is corrosion at the base of the water heater. As a result, this unit may need replacing at any time. Recommend budgeting for a replacement in the near future.

In addition, client should inquire with property owner as to the purpose of the catch pan below hot water heater, as this is not typical for water heaters. Furthermore, there is corrosion and water stains in and around the catch pan, further indicating that the water heater may need replacing in the very near future.

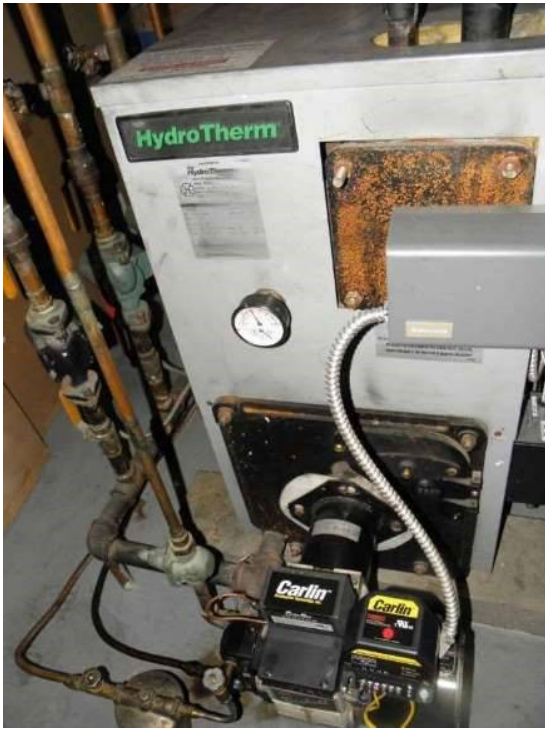
Photo 54-1

54) ✓ ⓘ The boiler appears to be in overall good condition. However, the service tags indicate that unit has not been serviced for more than six (6) years. As a result, unit may not be performing efficiently. Client should have unit serviced now and annually thereafter.

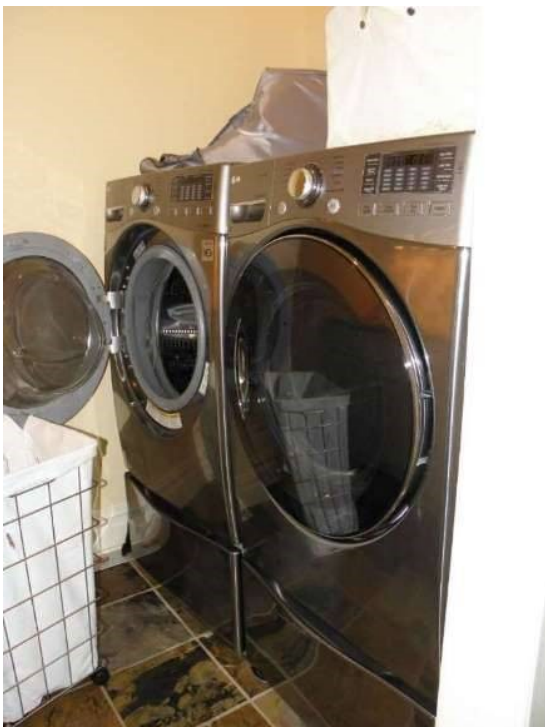
Photo 55-1

55) The clothes dryer is equipped with a foil, accordion-type, flexible exhaust duct. The U.S. Consumer Product Safety Commission considers these types of ducts to be unsafe, and a fire hazard. These types of ducts can trap lint and are susceptible to kinks or crushing, which can greatly reduce the air flow. This duct should be replaced with a rigid or corrugated semi-rigid metal duct, and by a qualified contractor if necessary. Most clothes dryer manufacturers specify the use of a rigid or corrugated semi-rigid metal duct. For more information on dryer safety issues, see <http://www.cpsc.gov/CPSC/PUBS/PUBS/5022.html>

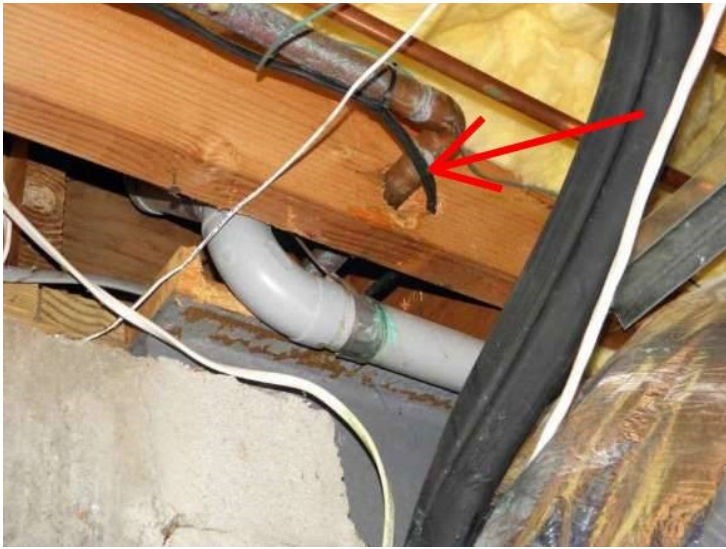
Photo 60-1

A hole was bored less than two inches from the edge of the floor joist. This is substandard construction and has damaged the floor joist. A qualified contractor should evaluate and repair as necessary.

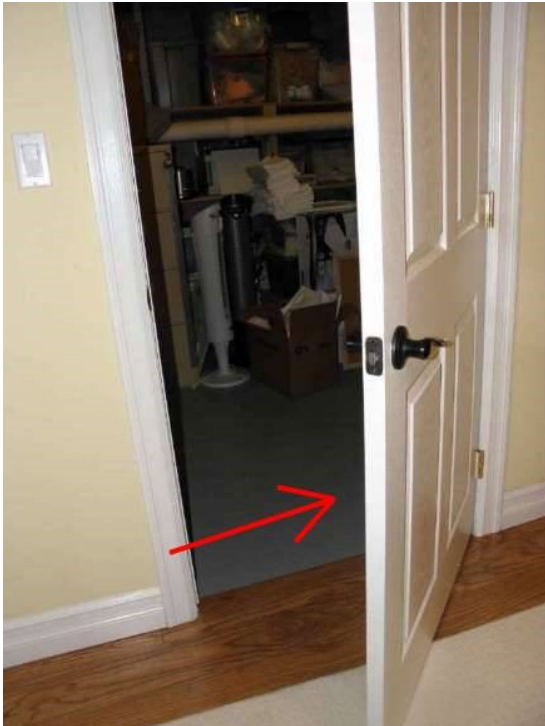
Photo 61-1

The boiler room is not equipped with a fire-rated (metal or solid-core construction) or vented door. This is a safety hazard due to risk of fire. A qualified contractor should replace door with a properly vented, fire-rated and self-closing door to prevent the spread of fire.

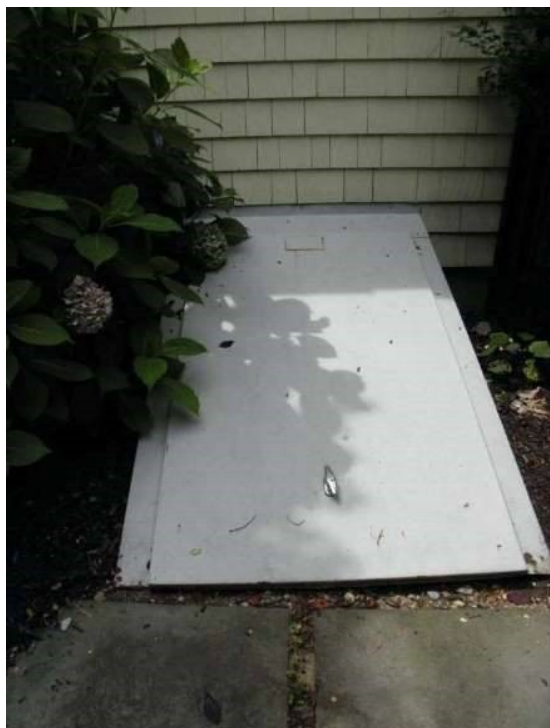
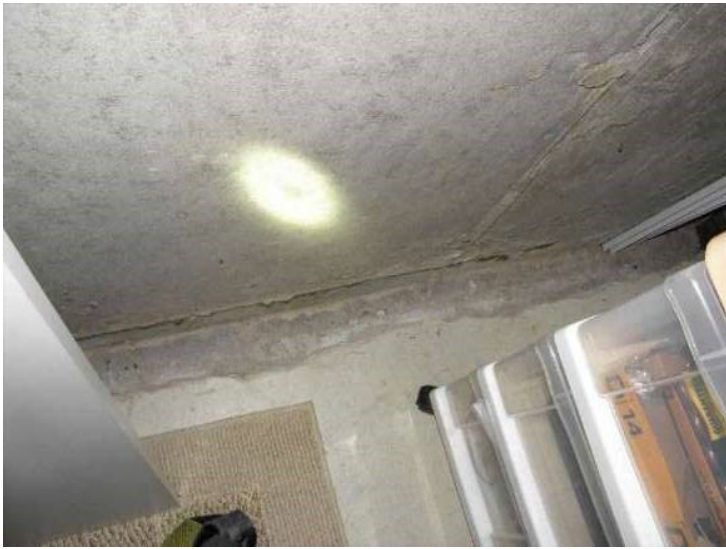
Evidence of prior water intrusion was found in one or more sections of the basement. For example, water stains and/or efflorescence on the foundation and basement entry walls. Accumulated water is a conducive condition for wood destroying insects and organisms and should not be present in the basement. The client should review any disclosure statements available and ask the property owner about past accumulation of water in the basement. The basement should be monitored in the future for accumulated water, especially after heavy and/or prolonged periods of rain. If water is found to accumulate, a qualified contractor who specializes in drainage issues should evaluate and repair as necessary. Typical repairs for preventing water from accumulating in the basement include:

- Repairing, installing or improving rain run-off systems (gutters, downspouts and extensions or drain lines)
- Improving perimeter grading
- Repairing, installing or improving underground footing and/or curtain drains

Ideally, water should not enter the basement, but if water must be controlled after it enters the basement, then typical repairs include installing sump pump(s) or interior perimeter drains.

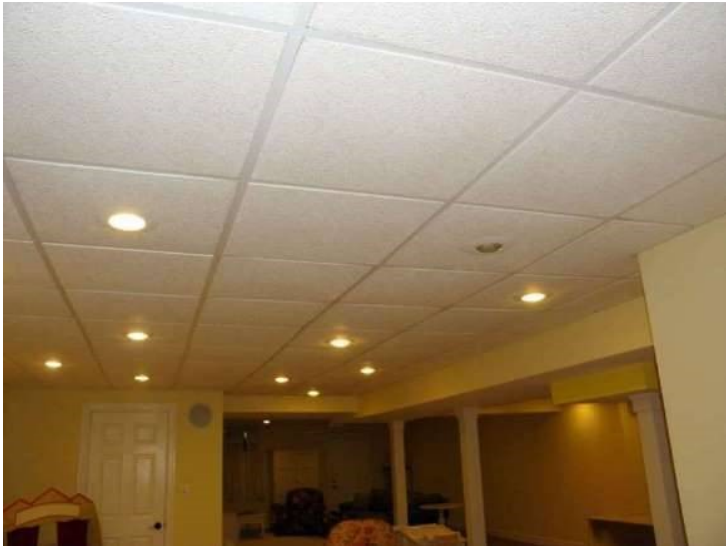
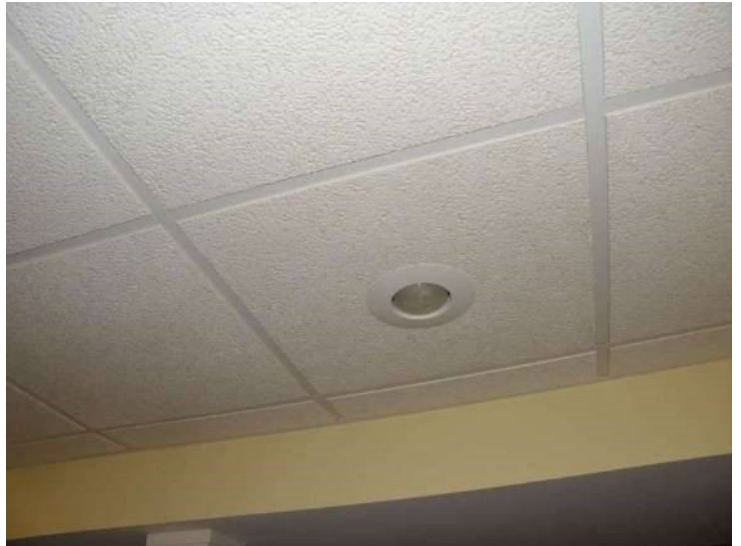
63) 🔍 One or more basement light fixtures appear to be inoperable. Recommend further evaluation by replacing bulbs and/or consulting with the property owner. Repairs or replacement of the light fixtures by a qualified electrician may be necessary.

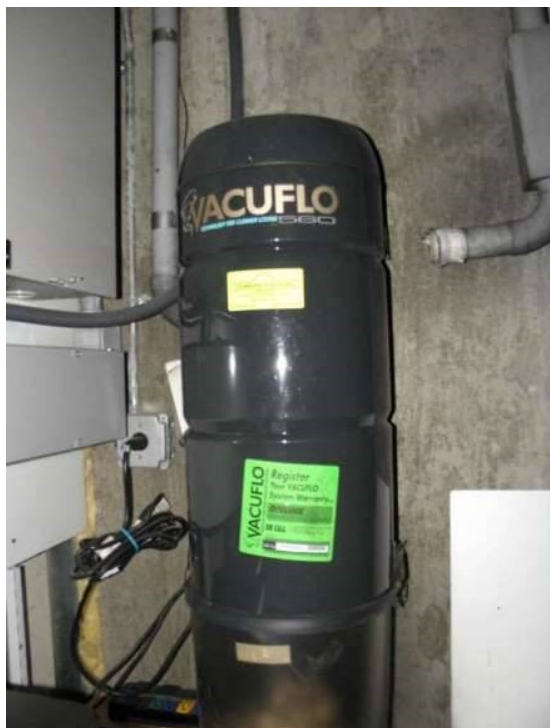
Photo 64-1

64) 🔍 ⓘ Central vacuum system for the basement only appears to be inoperable (while the main living space vacuum system appears to be in working condition). Although exempt from this inspection, it is recommended to have a qualified technician evaluate and make necessary repairs.
