SAMPLE INSPECTION REPORT

PROPERTY INSPECTION REPORT

Type of building: Single family

Age of building: Built in 2000 (as per MLS listing)

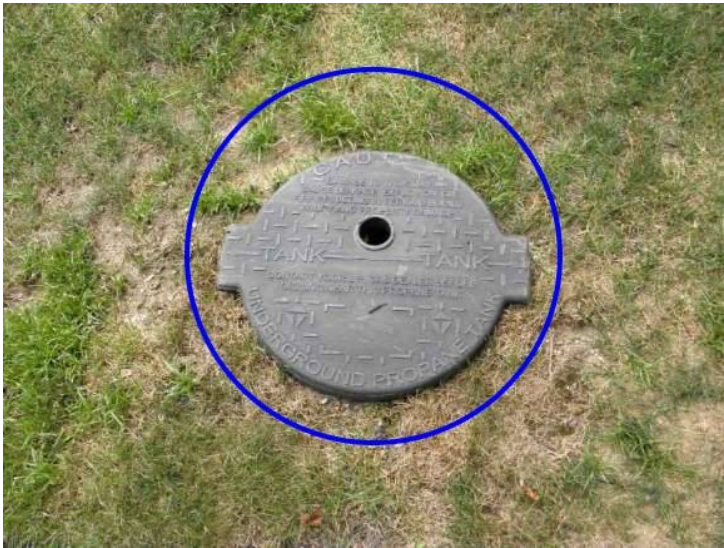
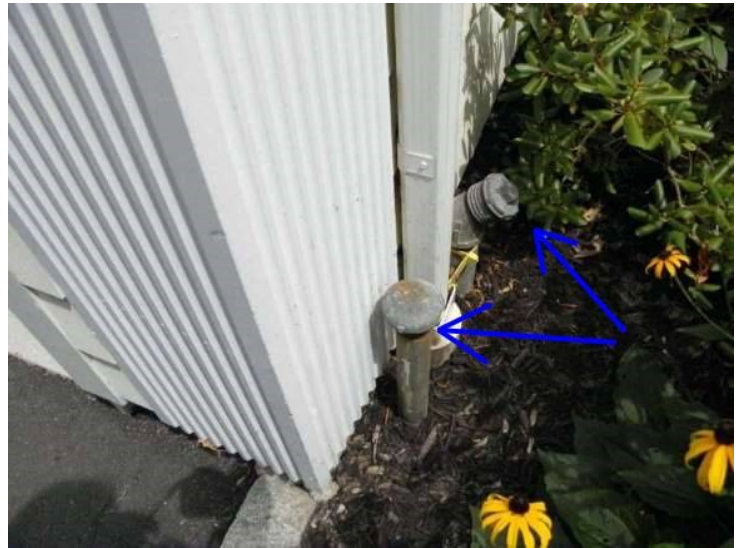
Property has buried propane and oil tanks. Client should inquire where tanks are buried and verify all required permits are on file.

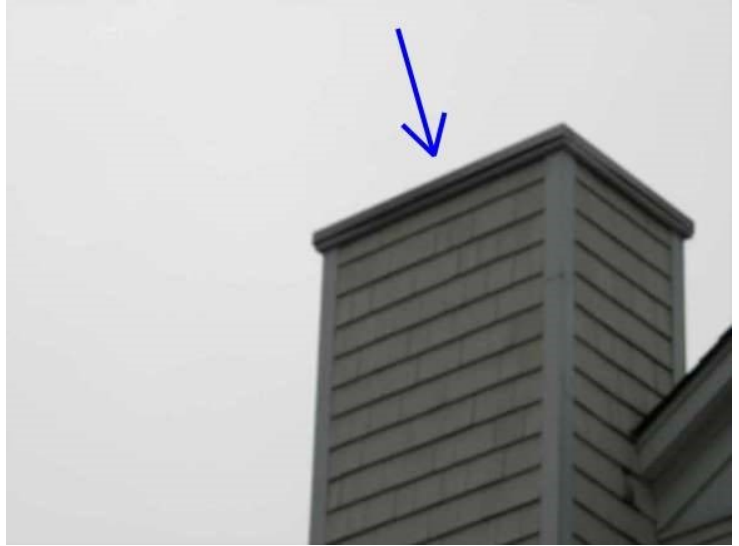
Photo 2-2 No vent on secondary chimney.

The home has two (2) chimney structures. Blue arrow indicates the chimney which does not appear to serve any wood-burning and/or gas fireplace, as well as any appliances requiring ventilation. Inspector was unable to determine the purpose nor find any vents associated with secondary chimney. Client should inquire with property owner about the intended purpose of this

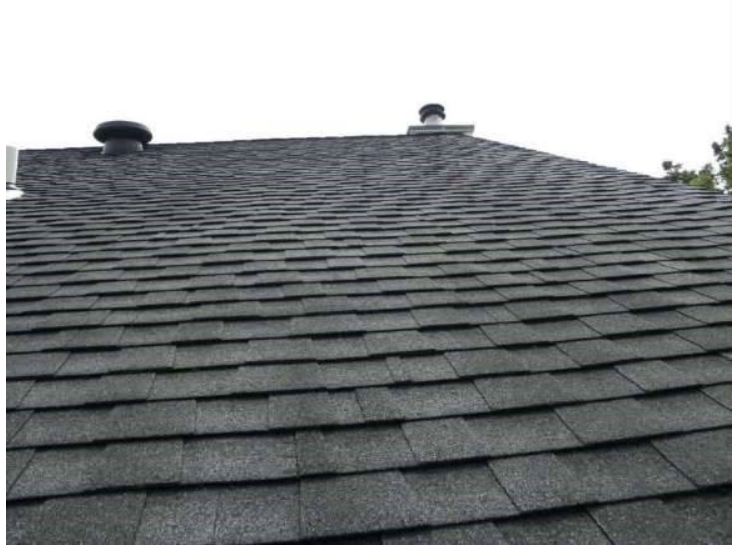
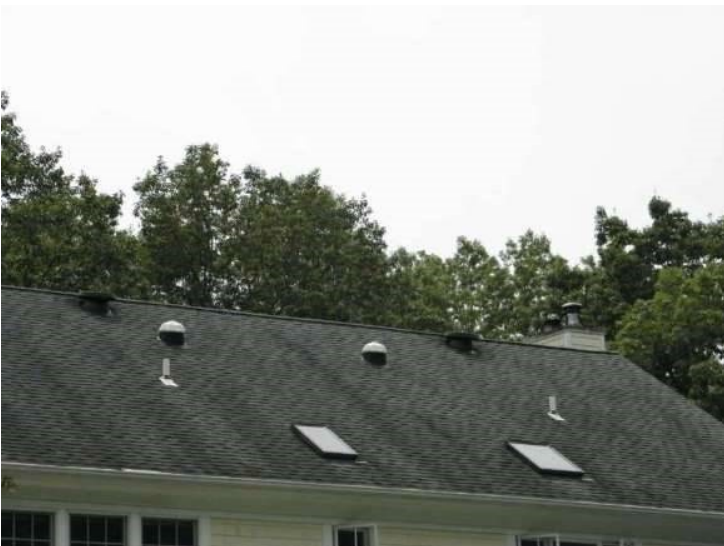
One or more composition shingles are damaged and/or deteriorated and should be replaced. Leaks may occur as a result. In addition, there are one or more areas of staining on the roof, which may be the result of rust from the chimney flue and an accumulation of moss build-up. A qualified roofing contractor should evaluate and make repairs as necessary.

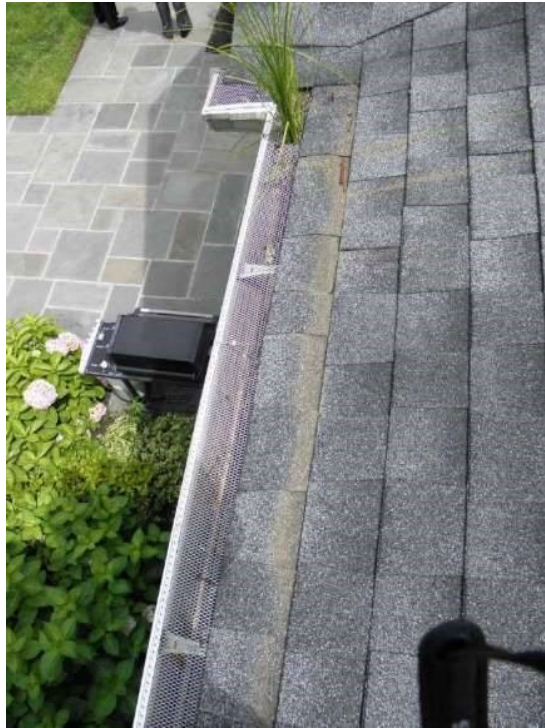
Photo 4-2

Debris has accumulated in one or more gutters. This is a conducive condition for wood destroying insects since gutters may overflow and cause water to come in contact with the structure's

exterior or make water accumulate around the foundation. Gutters should be cleaned now and as necessary in the future.

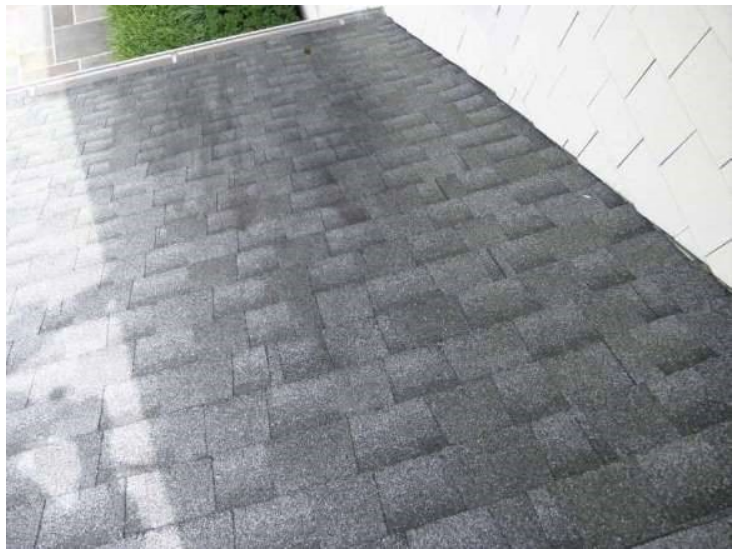
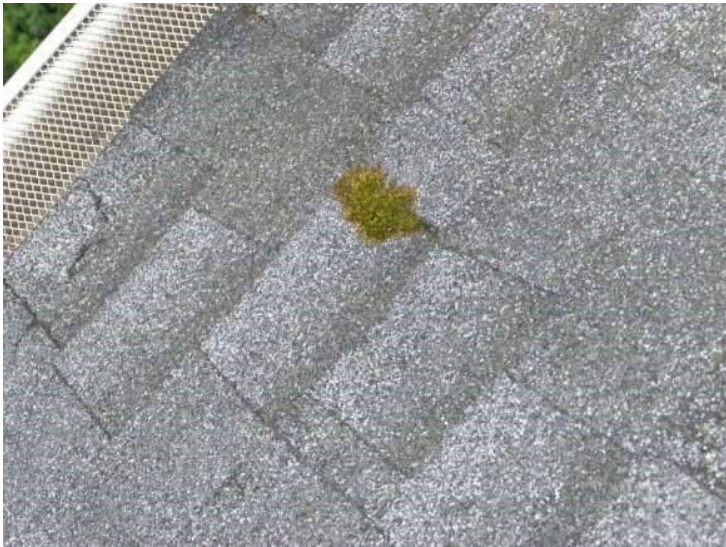
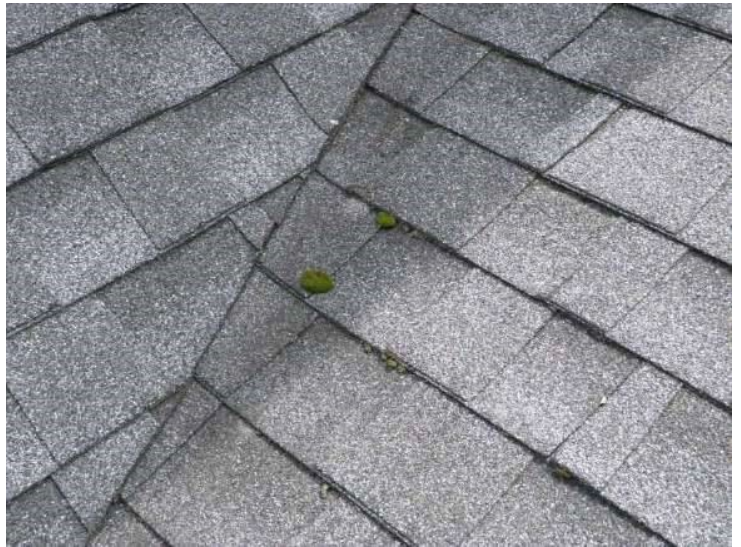
Moss is growing on the roof. As a result, shingles may lift or be damaged. Leaks may result and/or the roof surface may fail prematurely. This is a conducive condition for wood destroying insects and organisms. Efforts should be taken to kill the moss during its growing season (wet months). Typically zinc-based chemicals are used for this, and must be applied periodically. For information on various moss treatment products and their pros and cons, visit <http://bryophytes.science.oregonstate.edu/page24.htm>

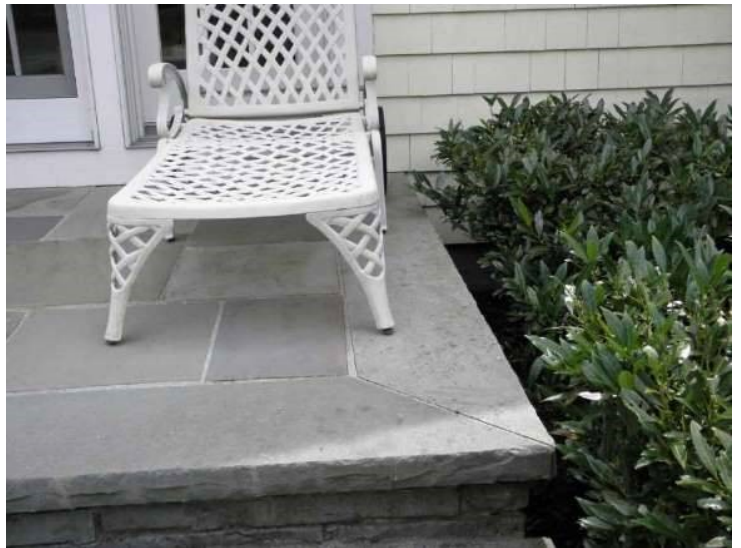
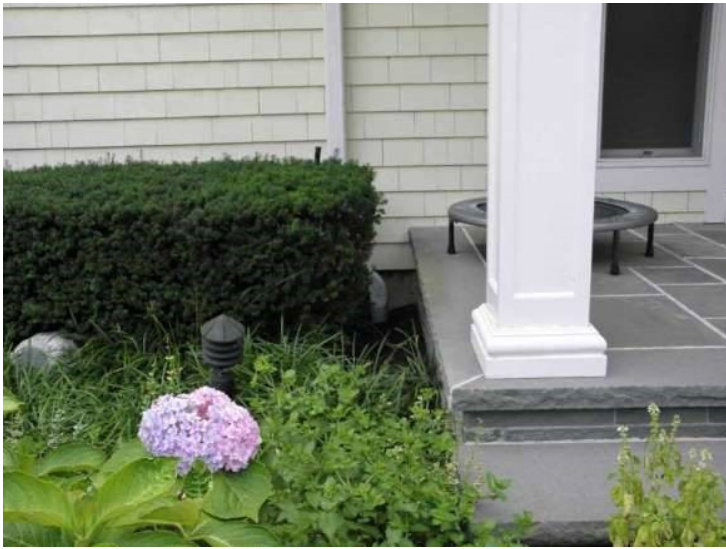
It is advisable to install handrails/guardrails where missing from sections of patio and/or elevated surfaces to reduce safety hazard due to the risk of falling. A qualified contractor should evaluate and install handrails/guardrails, as necessary and as per standard building practices.

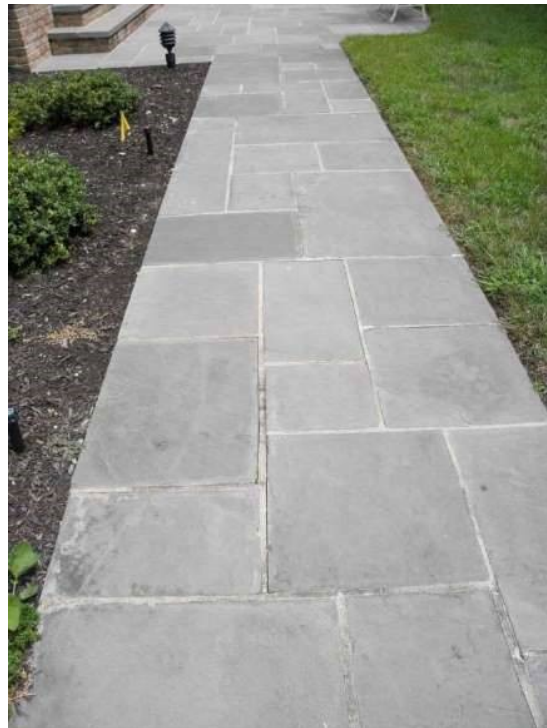
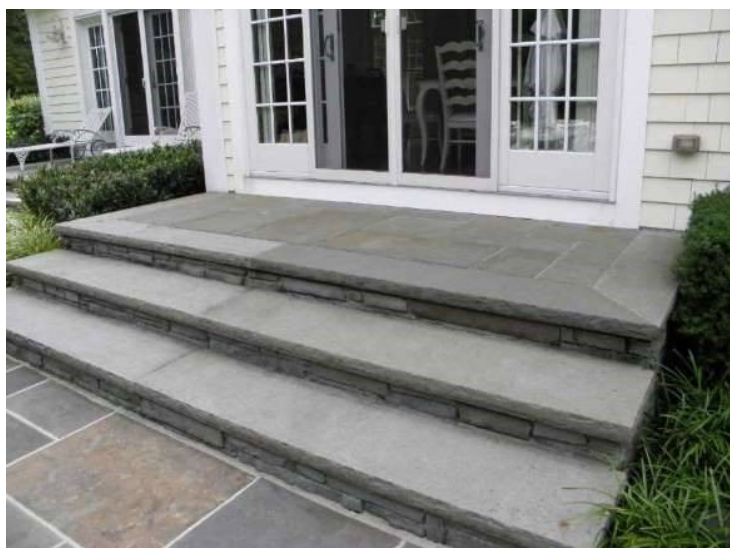
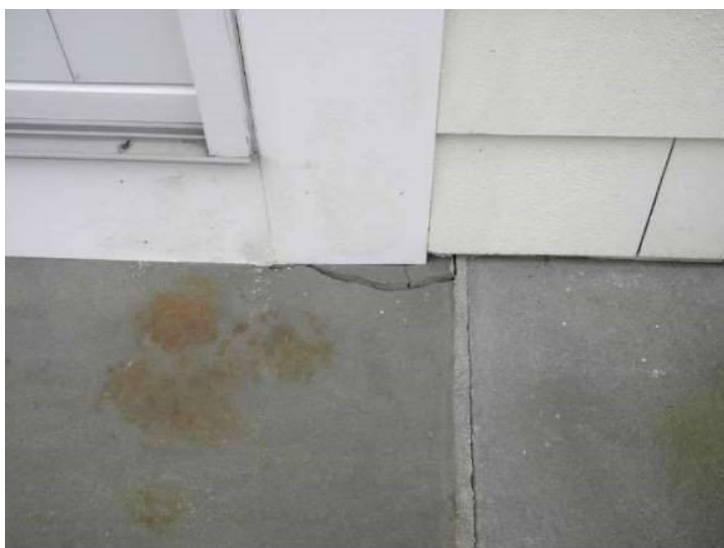
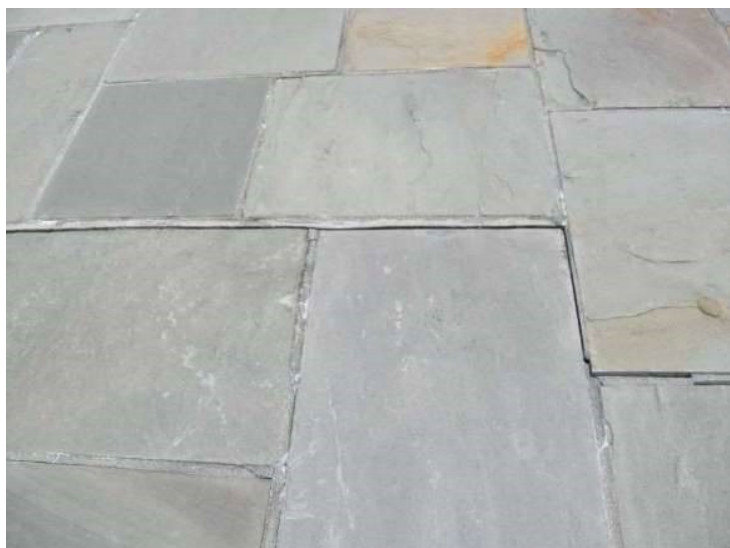
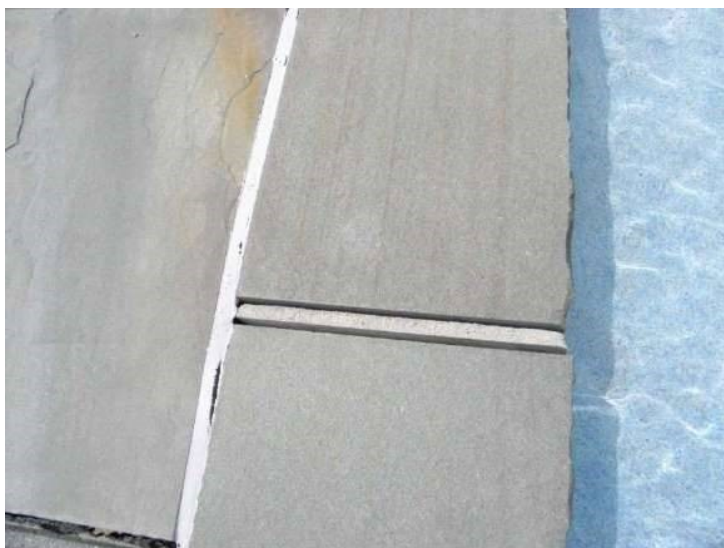
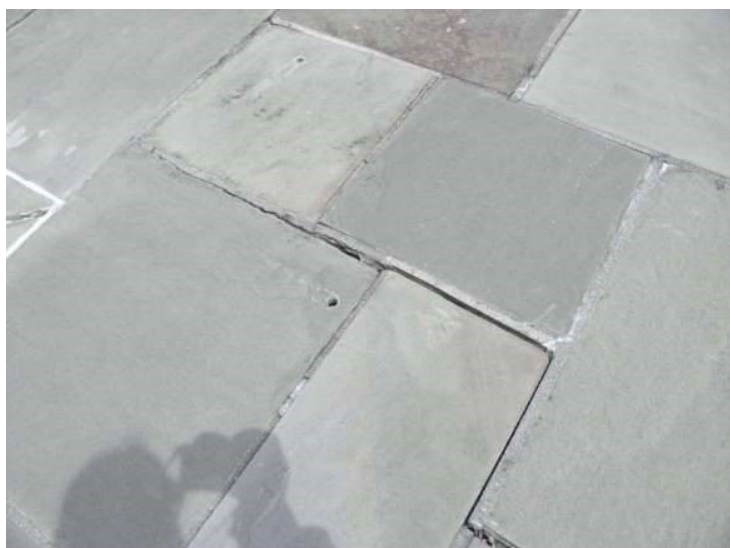
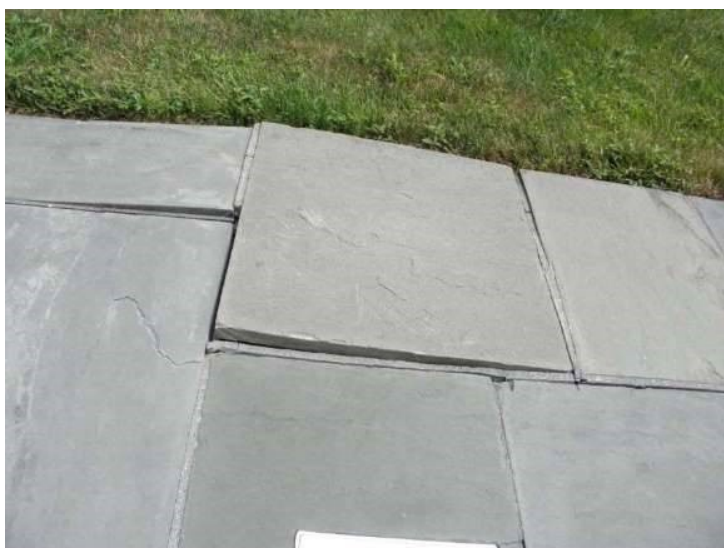
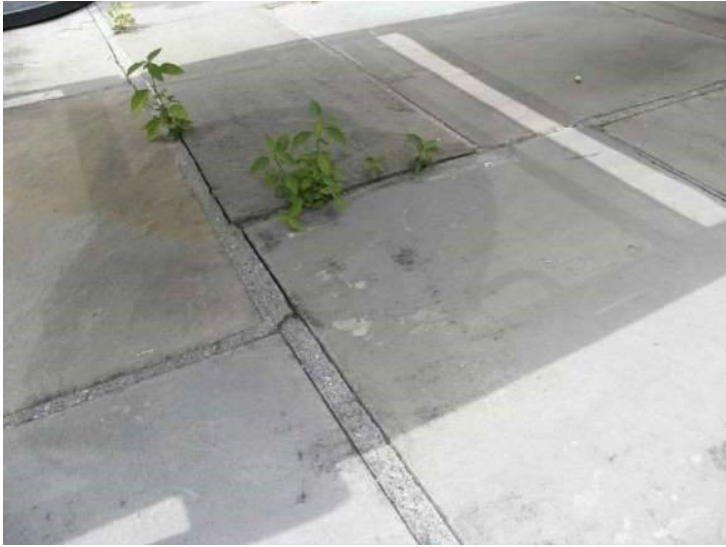
Several sections of blue stone surrounding pool and property have lifted, loose and/or damaged stones. These sections pose potential tripping hazards. A qualified contractor should evaluate and prescribe repairs and perform required maintenance, as needed.

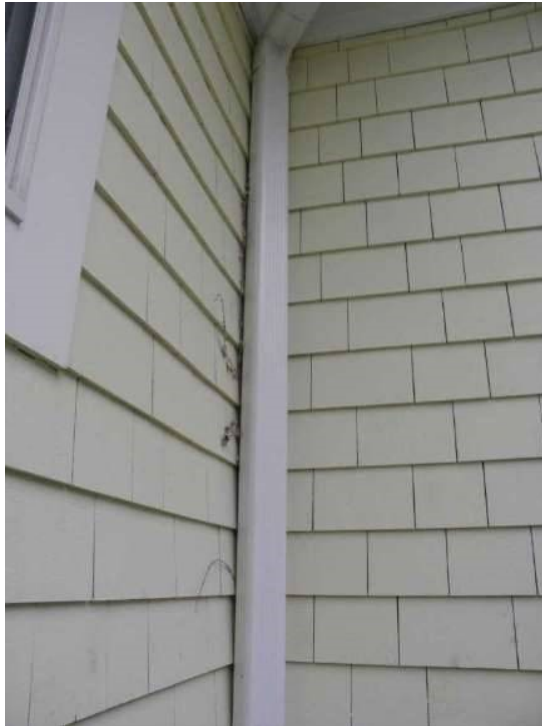
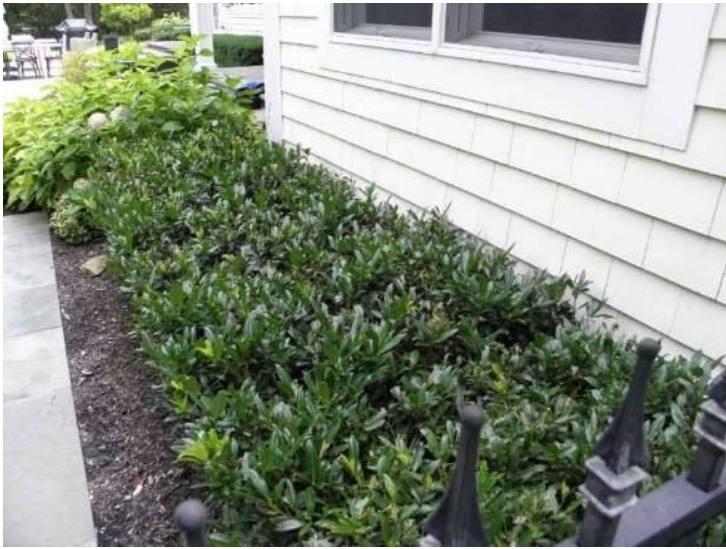
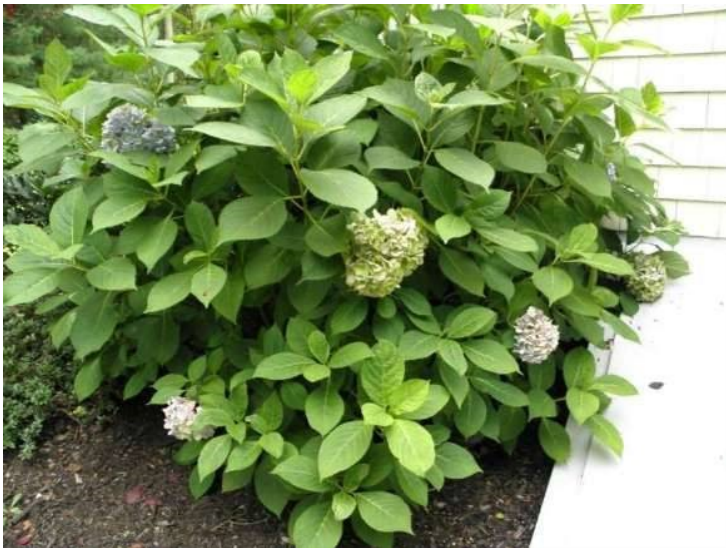
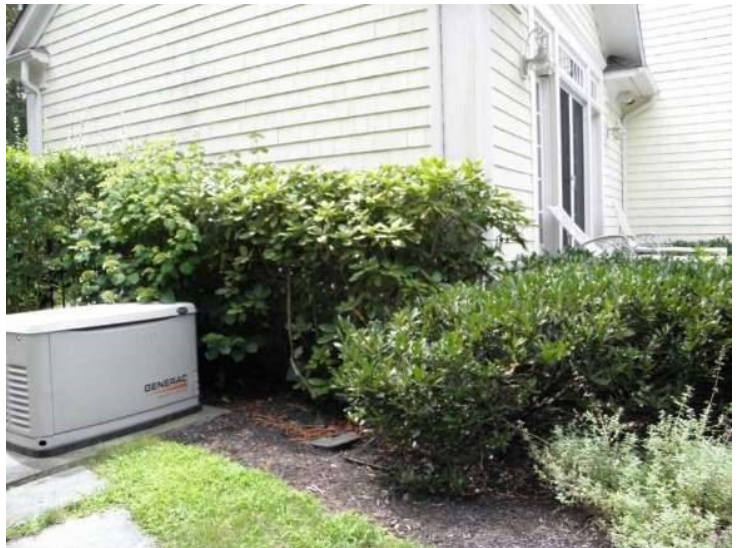
8) + Vegetation such as trees, shrubs and/or vines are in contact with or less than one foot from the structure's exterior. Vegetation can serve as a conduit for wood destroying insects and may retain moisture against the exterior after it rains. Vegetation should be pruned and/or removed as necessary to maintain a one foot clearance between it and the structure's exterior.

Furthermore, one or more sections of foundation and/or exterior walls are excluded from this inspection due to lack of access from vegetation and/or stored items.

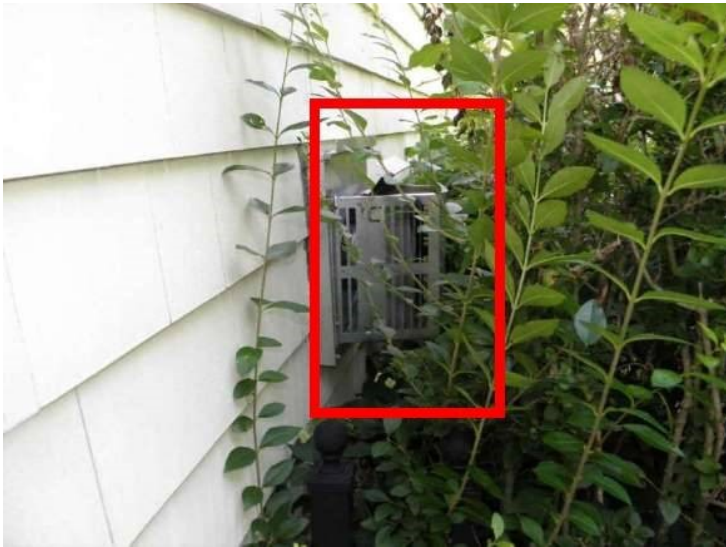
In addition, gas fireplace vent is obstructed by vegetation (where indicated by red box). This is a potential safety hazard. Area surrounding vent should be cleared as necessary.

Photo 8-9 Gas fireplace vent should be cleared of surrounding brush.

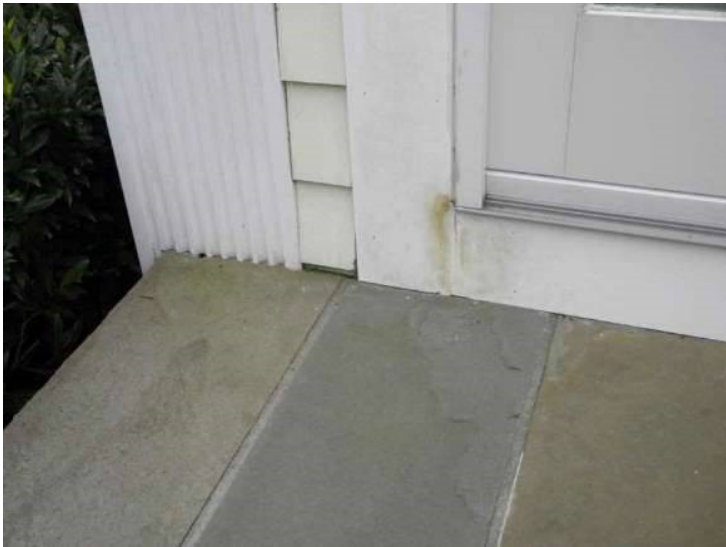
Photo 20-9

20) There are one or more loose wood shingles and areas where the wood shingle exterior finish is failing. A qualified contractor should prep (pressure wash, scrape, sand, prime, caulk, etc.) and repaint/re-caulk areas, as needed and as per standard building practices.

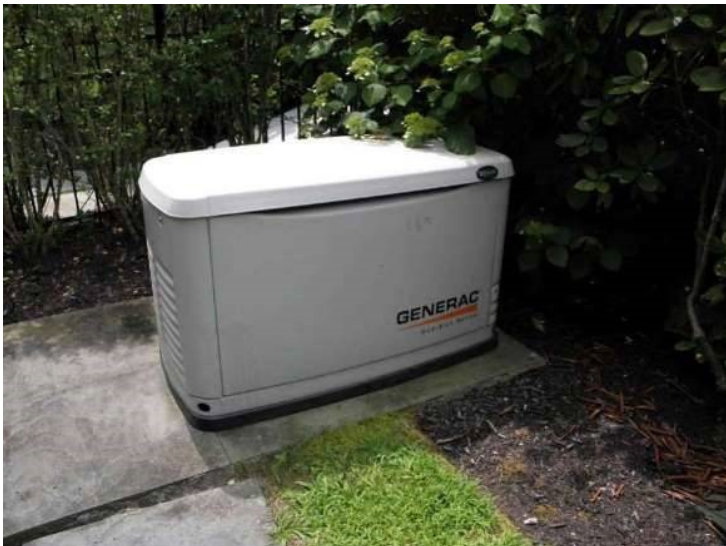
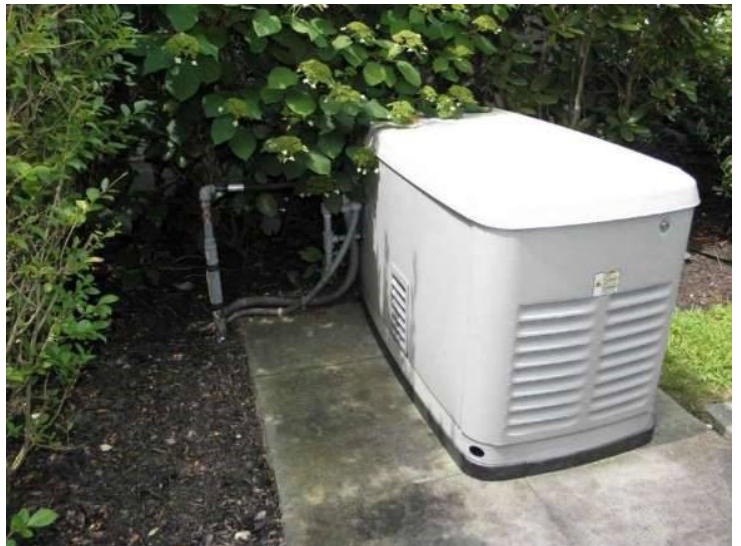
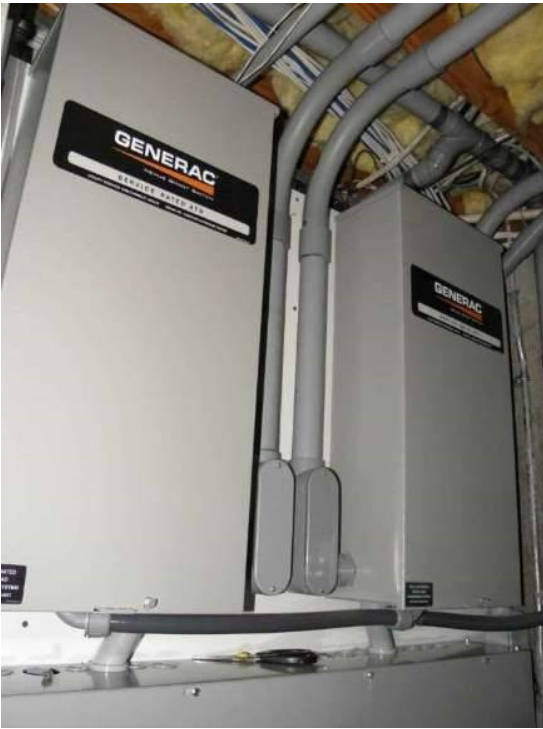
Home is equipped with a generator system in the event of a power failure. System was not tested and, therefore, exempt from this inspection and report. Client should obtain manual and warranty, if applicable, from the property owner.

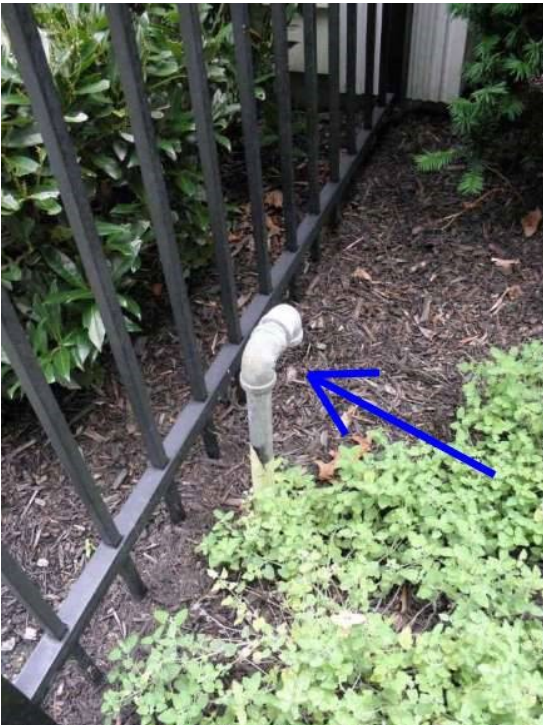
Photo 22-1

There is a pipe that has been capped, which appears to be an old gas line. Client should inquire with property owner about the nature and previous (or future) intended use of this capped pipe.

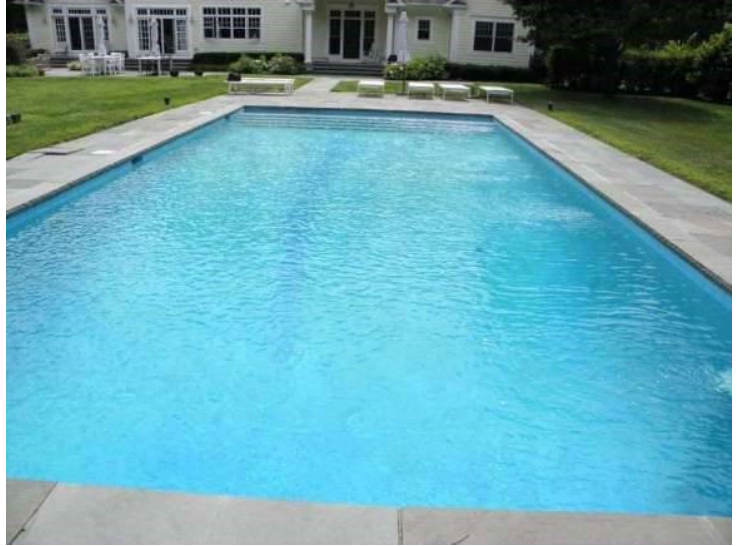
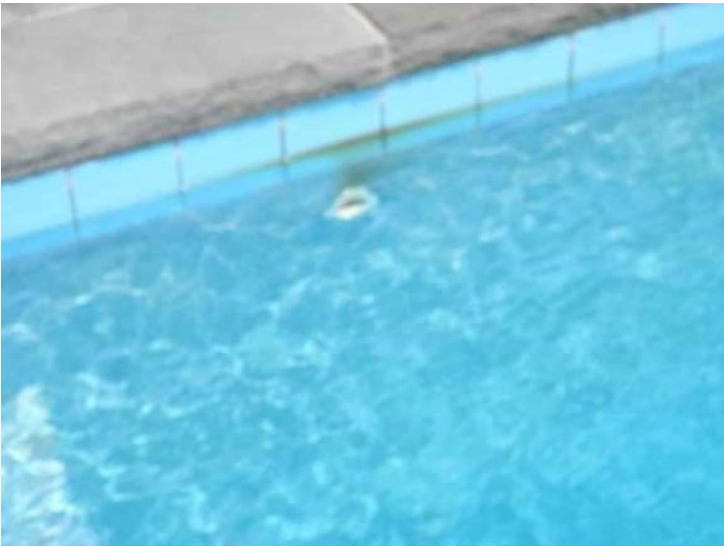
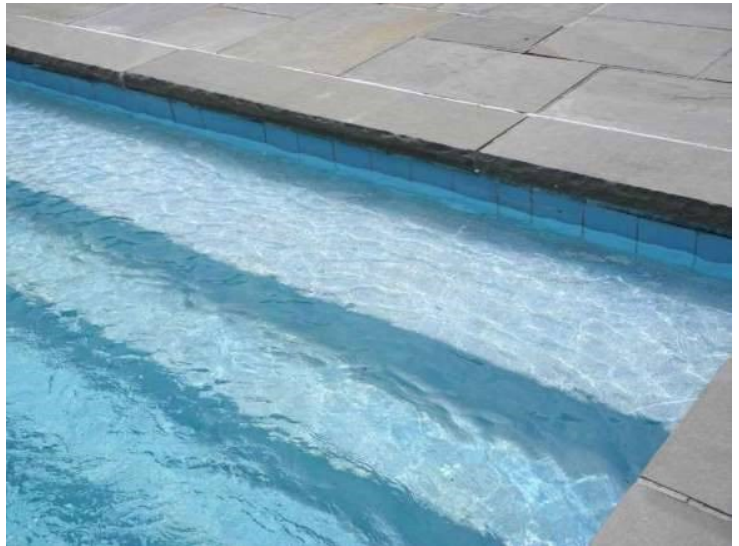
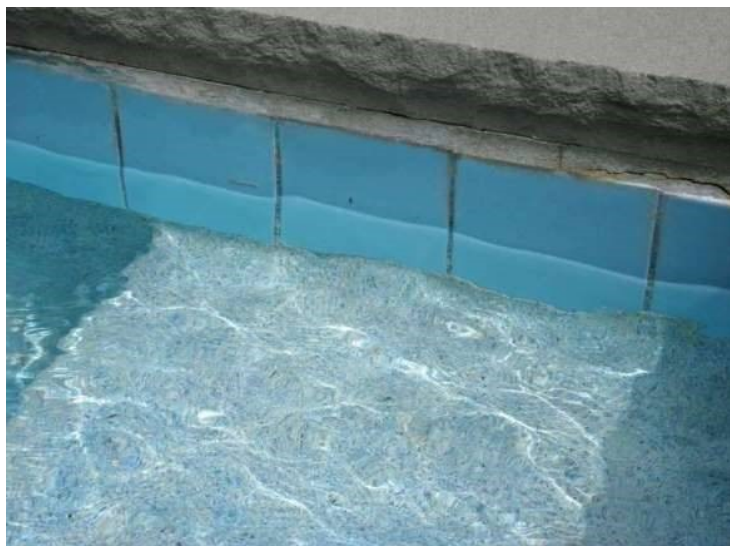
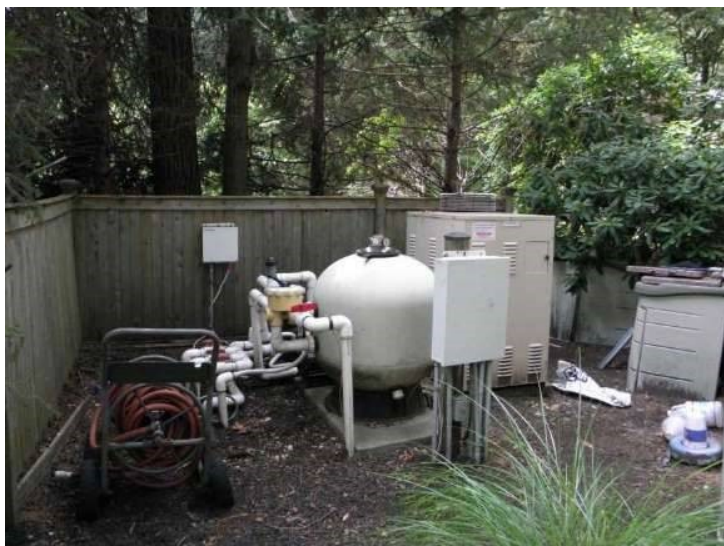
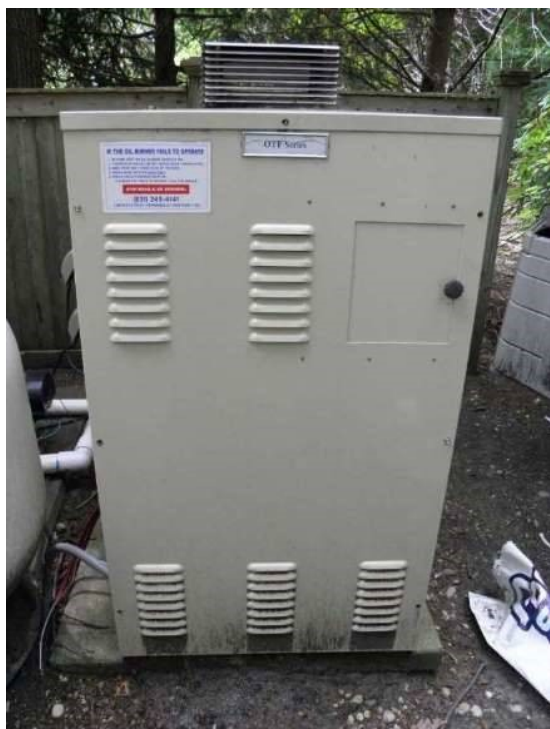
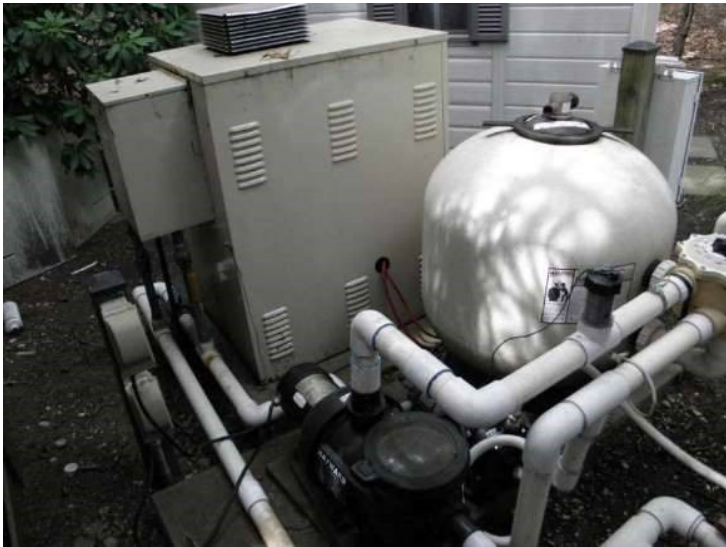
The Gunite pool appears to be in overall good condition. However, inspector noted a few areas of potential concern and/or inquires which should be made with property owner:

1. There appears to be minor deterioration to the pool tiles. Client should verify when pool surfaces were last refinished. Recommend having pool further evaluated by a qualified pool technician and maintenance/repairs performed as needed.

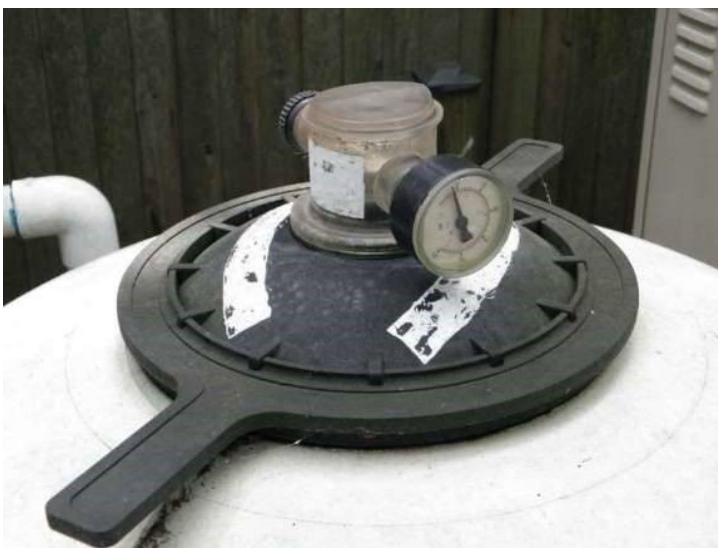
3. The filter pressure gauge appears to be inoperable. A qualified pool technician should evaluate and make necessary repairs/modifications.

Photo 23-8 Pressure gauge for pool filter

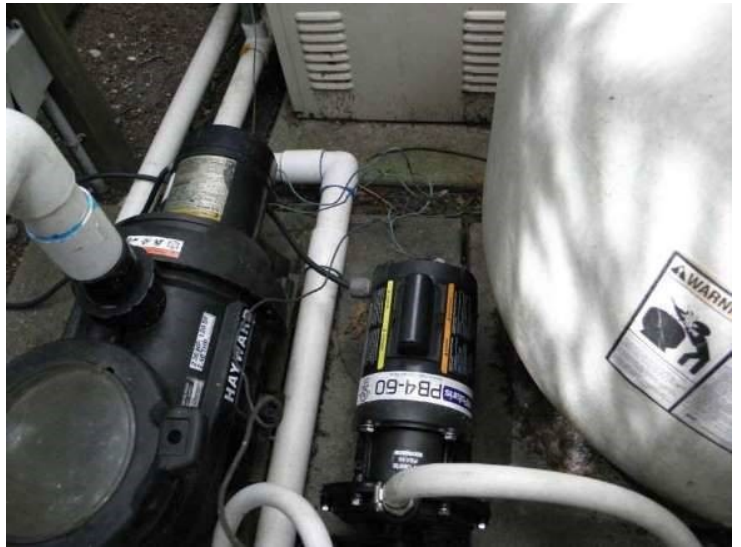
2. Inspector was unable to locate the ground rod. Ground rods are a necessary safety item to prevent risk of shock and damage to pool equipment. Client should inquire with property owner to determine the location of the ground rod.

Photo 23-10 Ground wires are connected, but no visible grounding rod appears to be present.

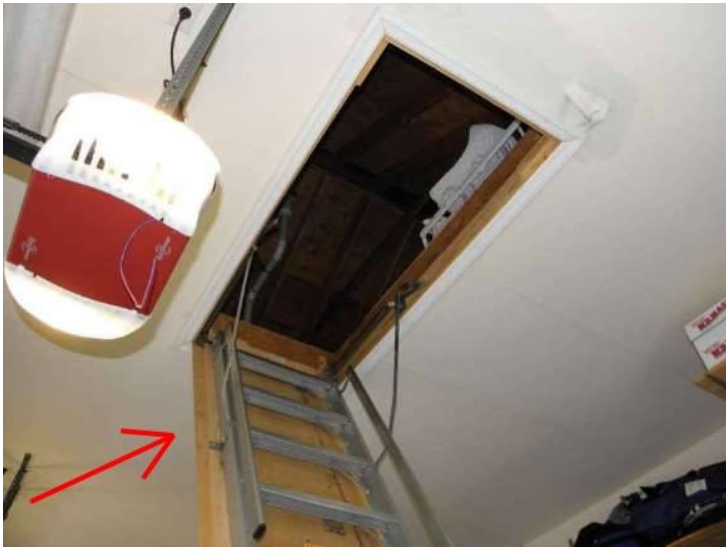
Photo 25-1

25) The pull-down attic stairs hatch cover is not fire-rated. This hatch cover should have a one-hour fire rating to slow or prevent the spread of fire from the attached garage to attic spaces above the living areas. A qualified contractor should evaluate and make modifications, as necessary, to ensure it has a one hour fire rating. Examples for modifications:

- Installing 5/8 inch Type X sheetrock on the lower surface of the stair door and eliminating gaps around the edges of the door.
- Removing the stairs and installing a traditional hatch made with 5/8 inch Type X sheetrock.
- Installing a [Battic Door](#) and installing sheetrock over it as described at their [website](#).

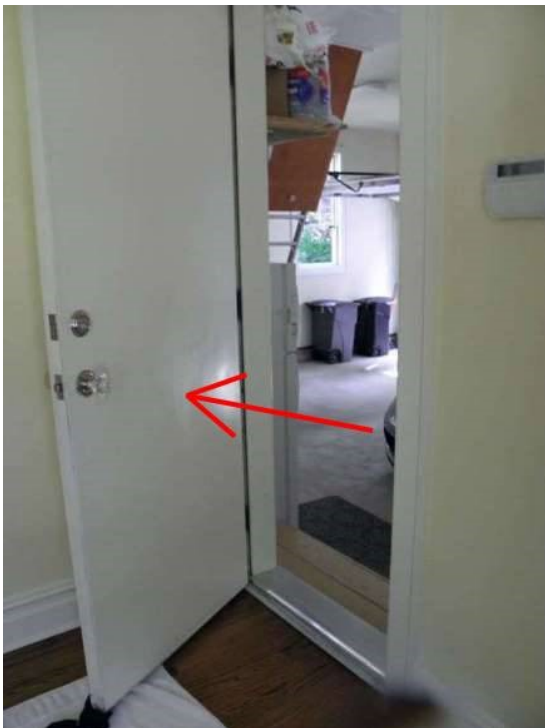
Photo 26-1

The interior door leading to and from the garage is not equipped with an automatic closing device, such as sprung hinges. This door should close and latch automatically to prevent vehicle fumes from entering living spaces and/or to slow the spread of fire from the garage to living spaces. A qualified contractor should install an automatic closing device, as necessary, and as per standard building practices, so this door closes and latches automatically.

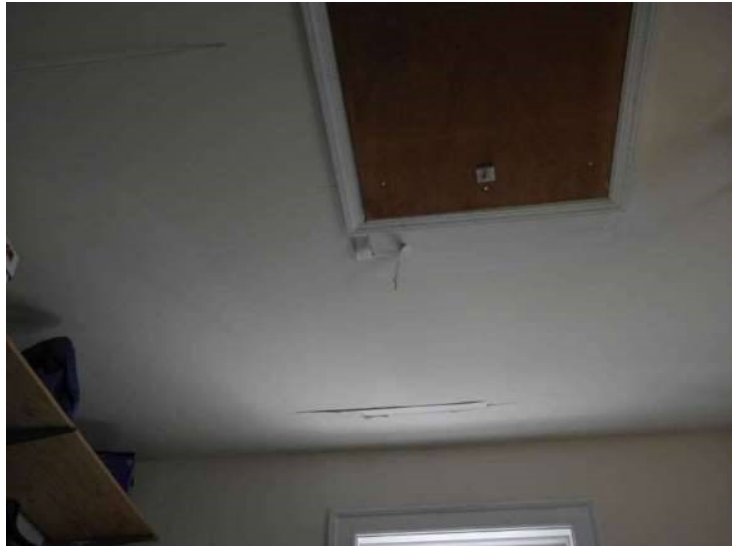
Photo 28-2

28) 🗝️ The garage ceiling surrounding the attic hatch is stained and deteriorated. This appears to be the result of an active or previous roof leak. Upon confirming that there are no active roof leaks, repairs should be made to the garage ceiling, as necessary and as per standard building practices.

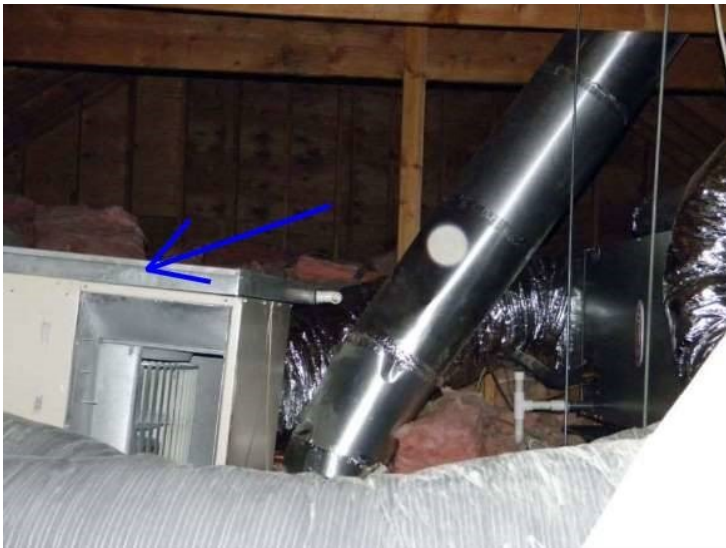
Photo 29-3

29) 🔍 Several areas of the attic could not be fully evaluated due to excessive stored items. As a result, inspector was unable to determine if the air handler (indicated by the blue arrow) is active, operable or disconnected. A qualified contractor should evaluate and determine what, if any, repairs/modifications are needed as per standard building practices.

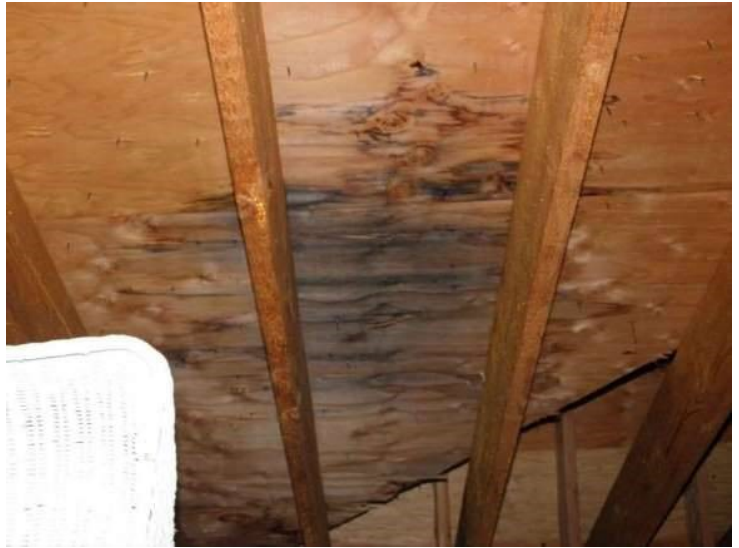
Photo 31-2

Stains were visible on the roof structure in one or more areas. These areas were dry at the time of the inspection. The stains may be caused by an active or past leak. Recommend asking the property owner about past leaks. The client should monitor these areas in the future, especially after heavy rains, to determine if active leaks exist. If leaks are found, a qualified roofing contractor should evaluate and repair as necessary.

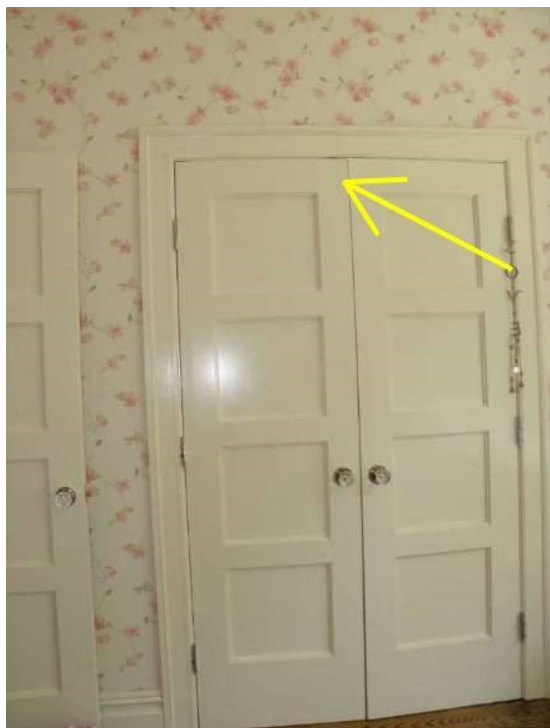
Photo 37-1

The interior bedroom door binds in its jamb and is difficult to close. Modifications/adjusting jambs should be made as necessary.

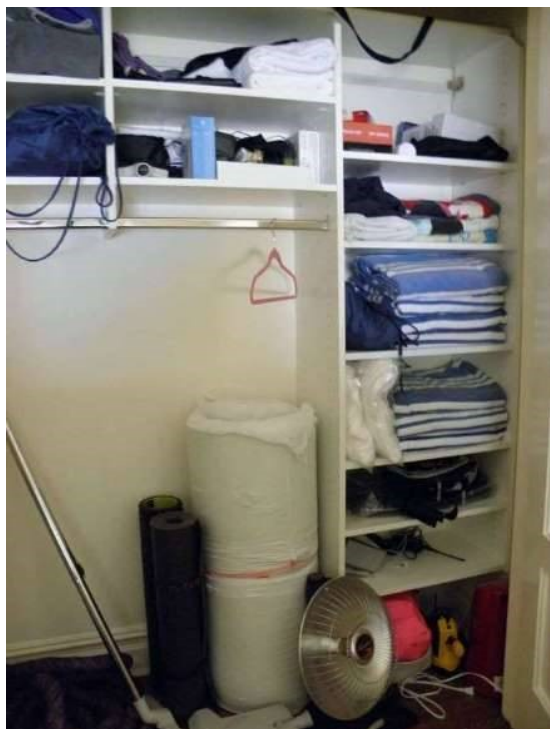
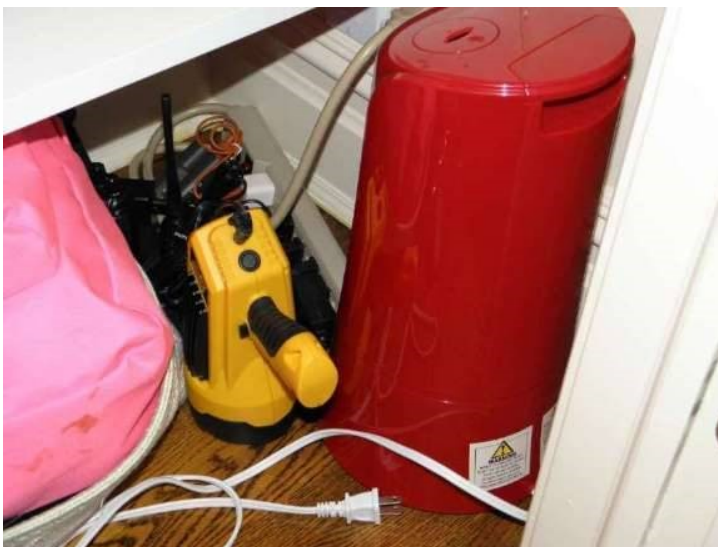
38) **i** One or more interior closets could not be fully evaluated due to excessive stored items. As a result, these areas are exempt from this inspection and report.

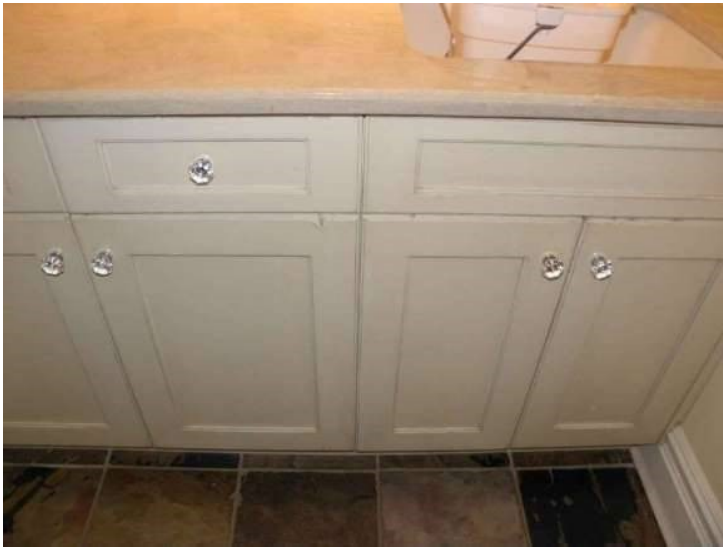
Photo 39-2

39) **i** The cabinets located in the laundry room have one or more areas of wear and deterioration.

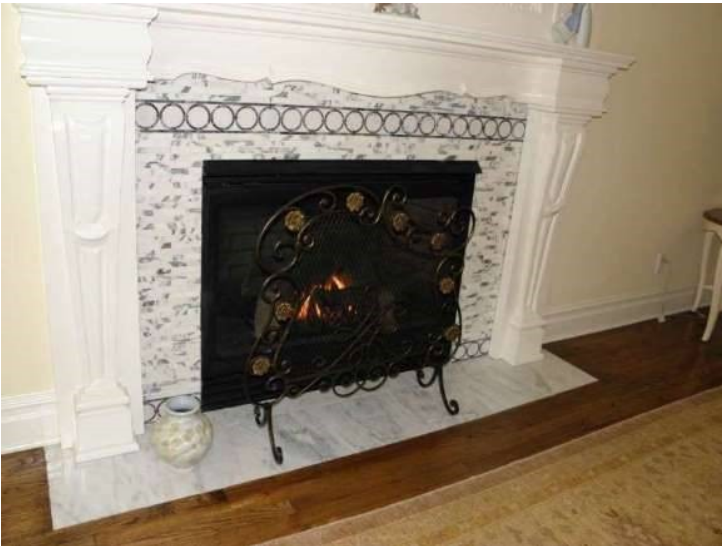
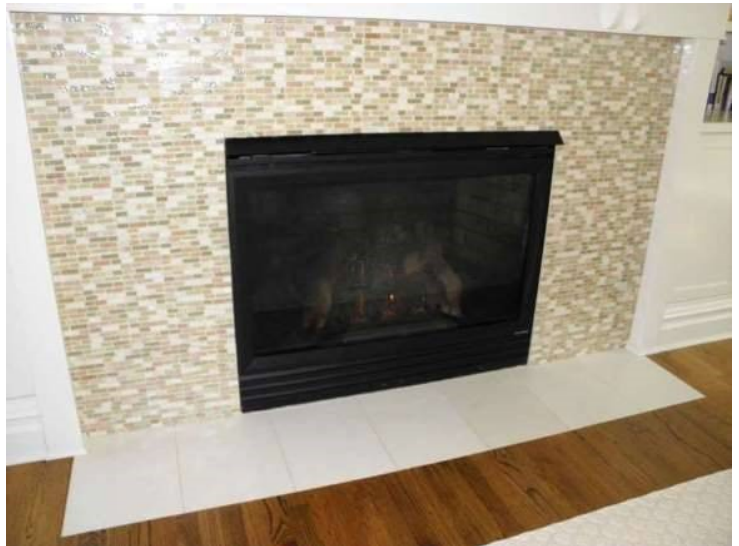
At the time of inspection, gas fireplaces were tested and found to be in working condition. Client should obtain remote controls, instruction manuals and warranties, if applicable, from the property owner.

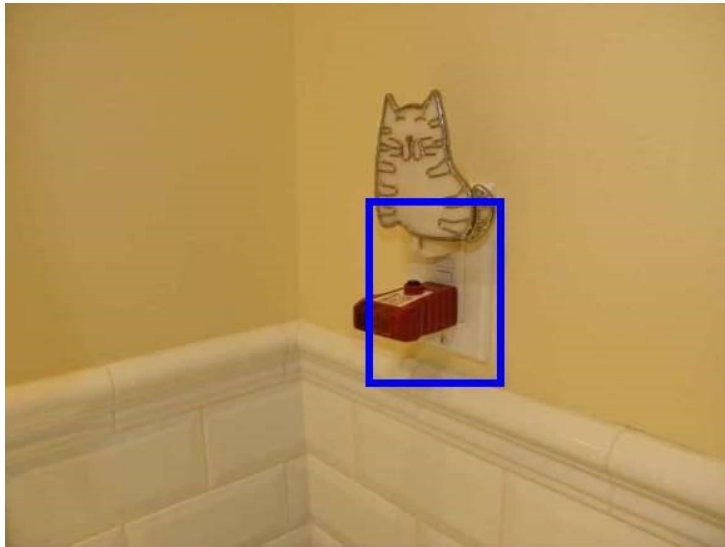
Photo 41-2

The upper-level bathroom electric receptacle had no power at the time of inspection. Recommend asking the property owner about this. Switches may need to be operated to make some receptacles energized. If necessary, a qualified electrician should evaluate and make repairs as necessary.

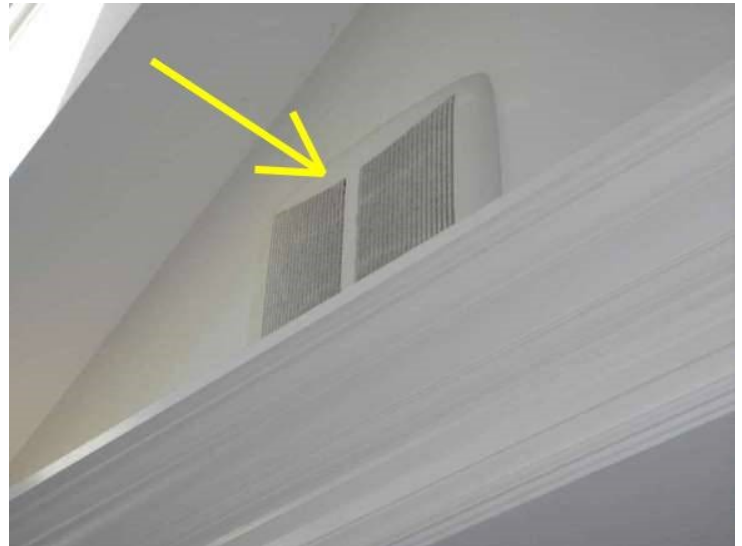
Photo 42-2

One or more exhaust fans in the upper-level bathrooms are inoperable or provide inadequate air flow. Moisture may accumulate as a result. A qualified contractor should evaluate and repair or replace exhaust fans, as necessary.
