SAMPLE INSPECTION REPORT

PROPERTY INSPECTION REPORT

Type of building: Single family

Age of building: Built in 2000 (as per MLS listing)

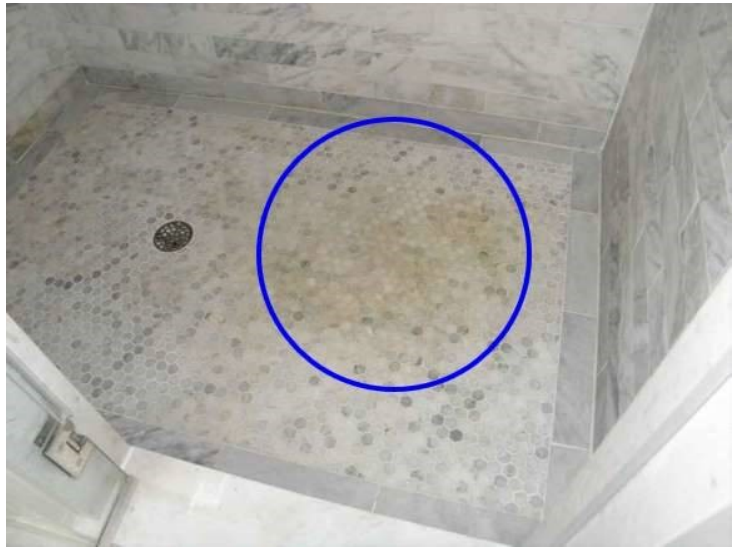
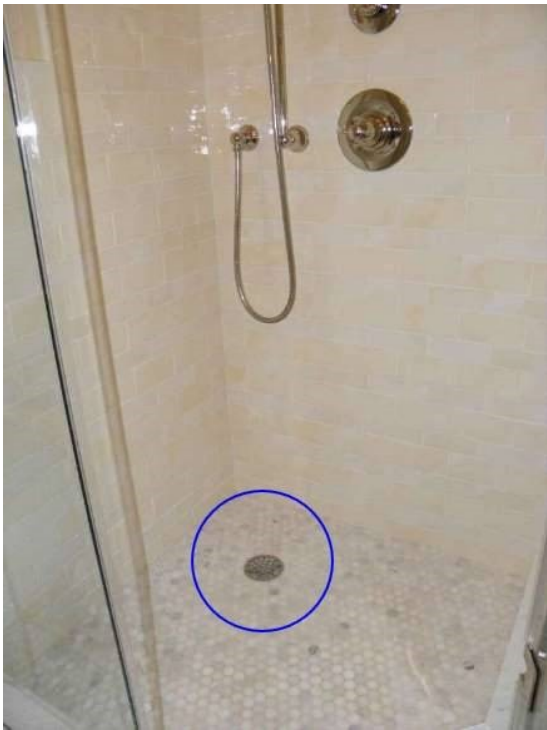
Grout in one or more showers is discolored and/or missing. A qualified contractor should evaluate and replace grout, as necessary.

In addition, there is staining at the base of one or more showers (where indicated by blue circles). This staining appears to be the result of standing/pooling water that did not properly drain. Client may wish to have these areas further evaluated by a qualified contractor and modifications made to prevent further discoloration and/or damage to the surrounding structure.

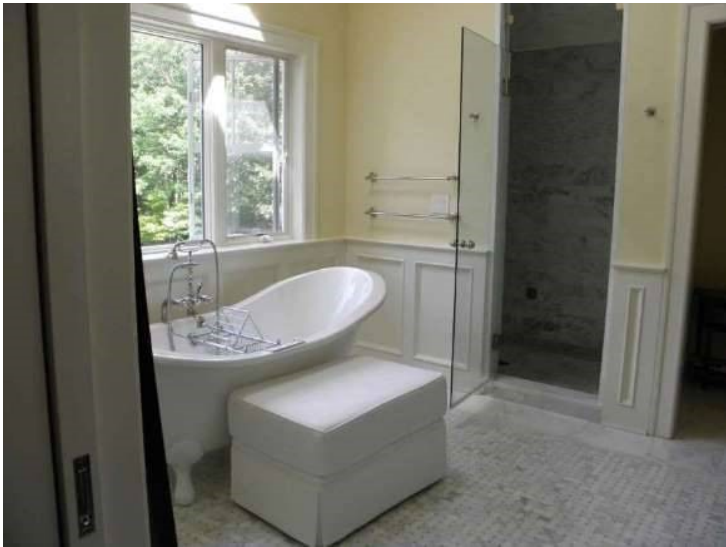
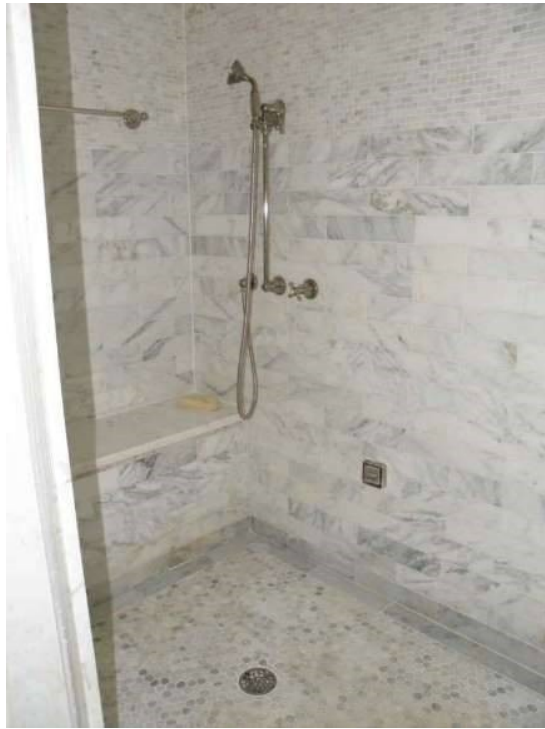
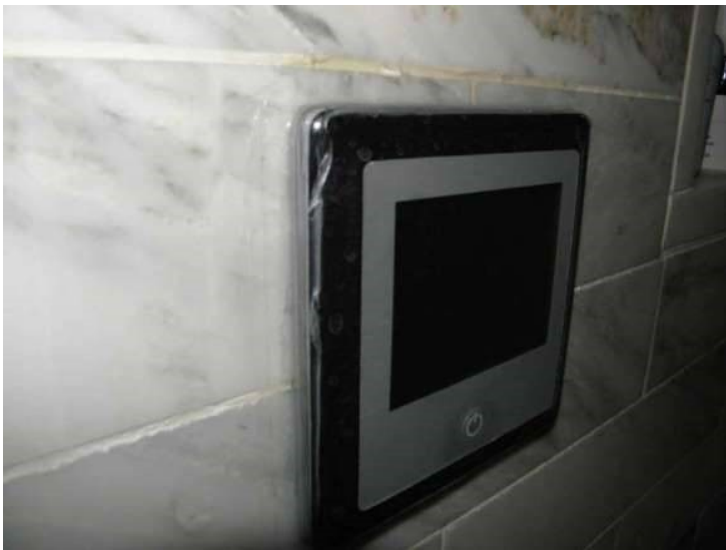
Master bathroom is equipped with a steam system for the shower. The steam control pad, located inside the shower, was covered by an adhesive tape. The steam system was not operated or tested at the time of inspection and, therefore, is exempt from this inspection and report. Client should obtain instruction manual for operating system from the property owner so that system can be evaluated, tested and utilized.

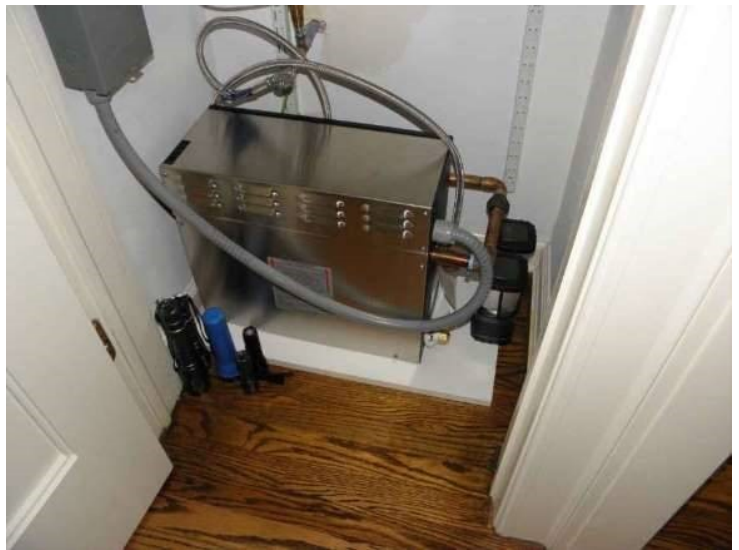
Photo 44-4 Steam system located in hallway closet.

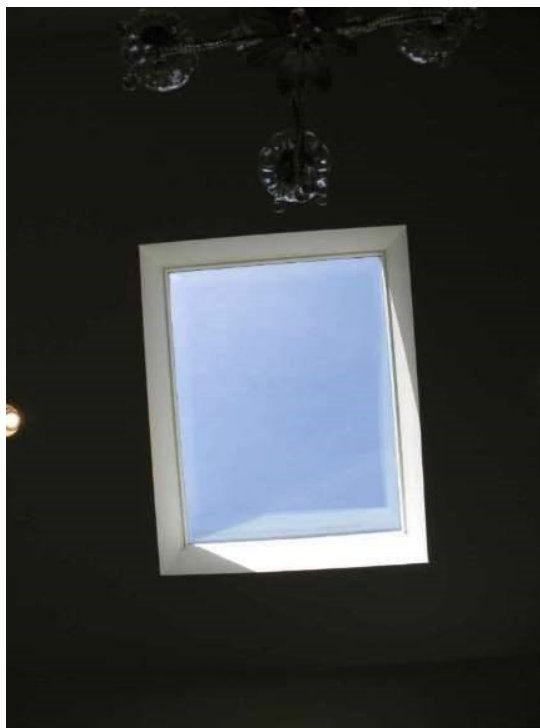
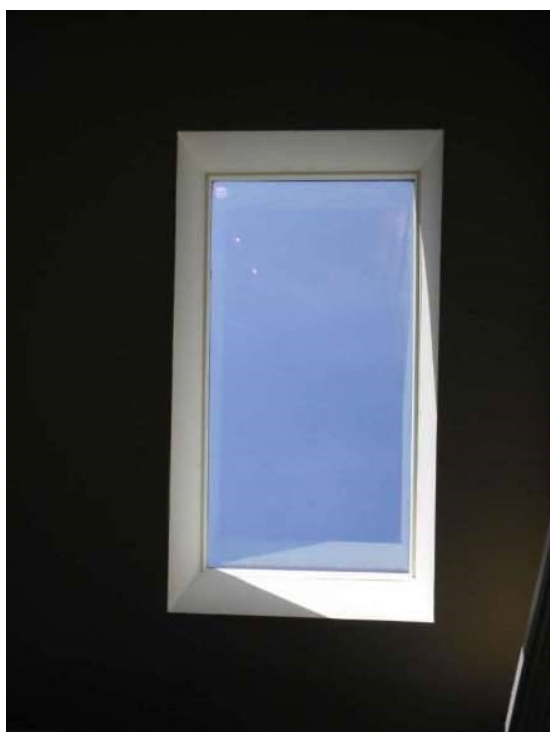
The bathroom ceiling and skylights show signs of moisture in one or more areas, as evidenced by stains and discoloration. This may be the result of an active or past leak or moisture build-up due to ineffective or inoperable exhaust fans. Further evaluation is recommended by a qualified contractor.

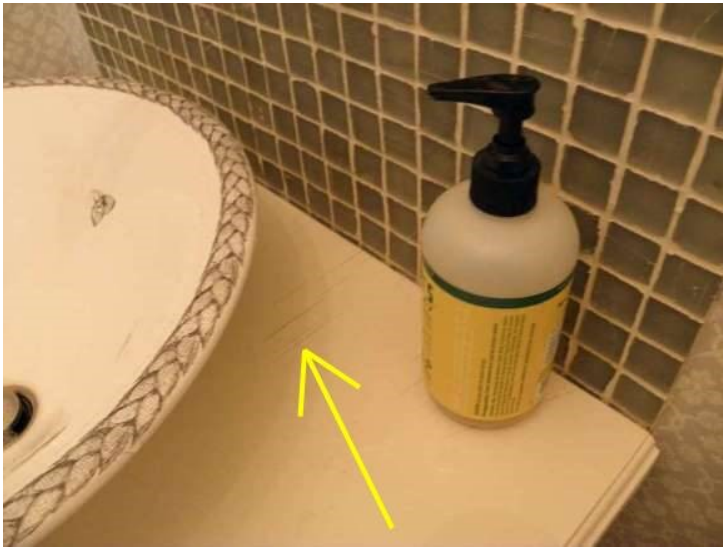
Photo 46-2

46) Lower-level half bath does not appear to have a source of heating or cooling.

In addition, there is minor deterioration to the sink countertop.

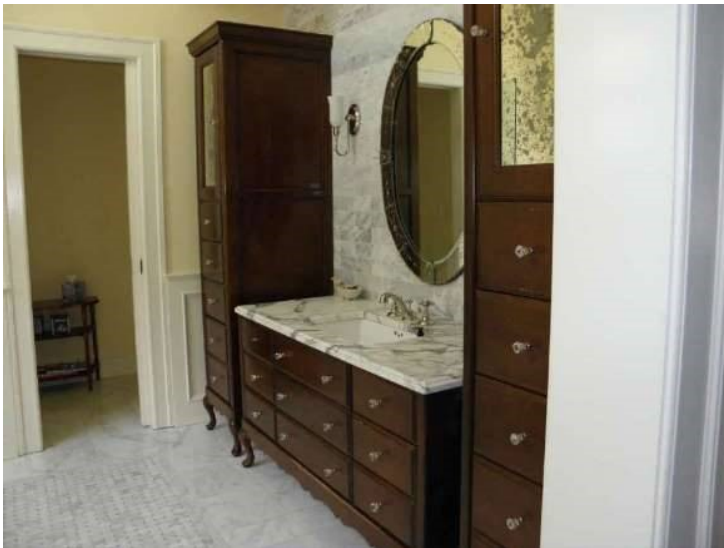
Photo 47-1

The master bathroom appears to have radiant heat (as the floors were warm when walked upon at the time of inspection), however, this could not be confirmed as inspector was unable to locate the controls. As a result, radiant heat floor, if present, is exempt from this inspection and report. Client should confirm presence of radiant heat and inquire about location of controls with property owner.

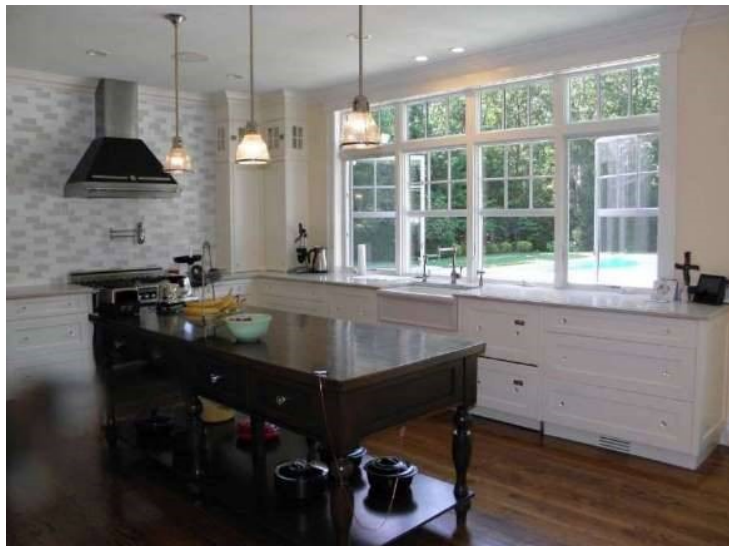
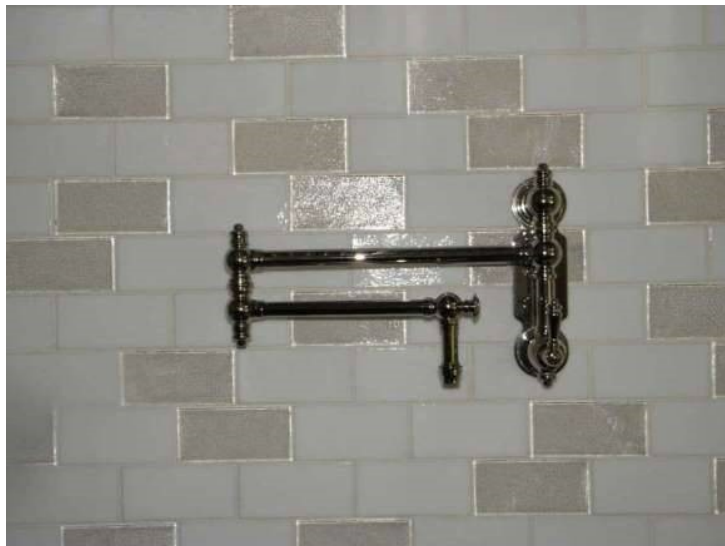
49) ⓘ It is advisable for the client to obtain instruction manuals and warranties, if applicable, for the kitchen pot filler, dishwasher, stove and water filtration system.

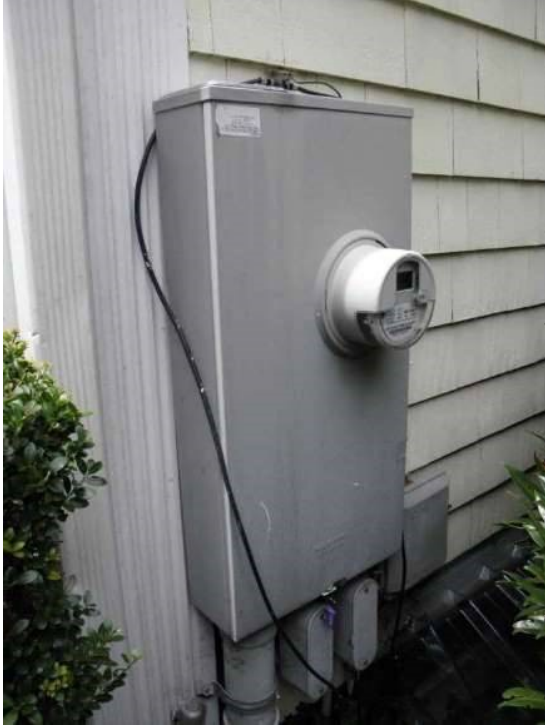
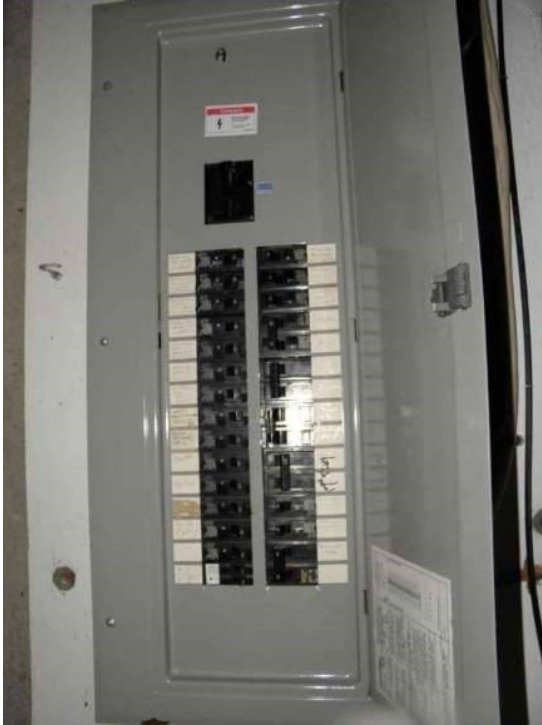
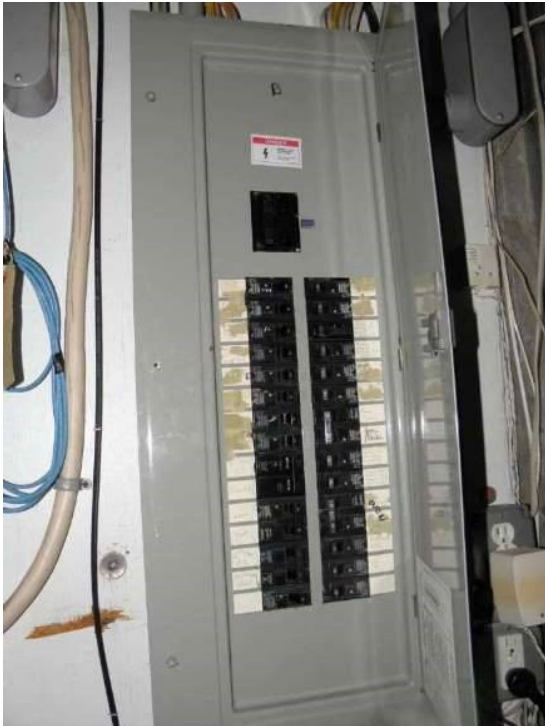
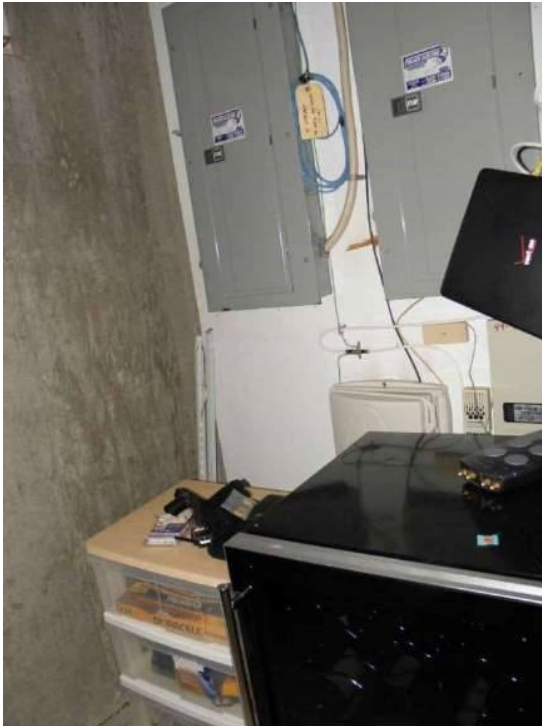
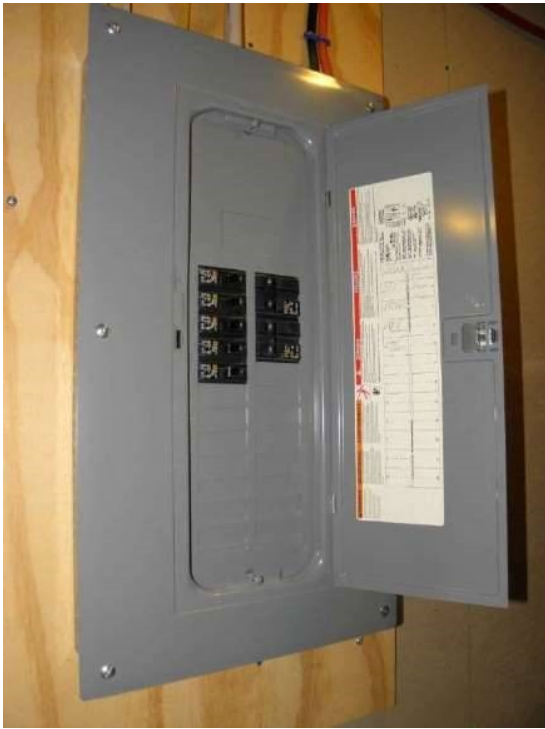
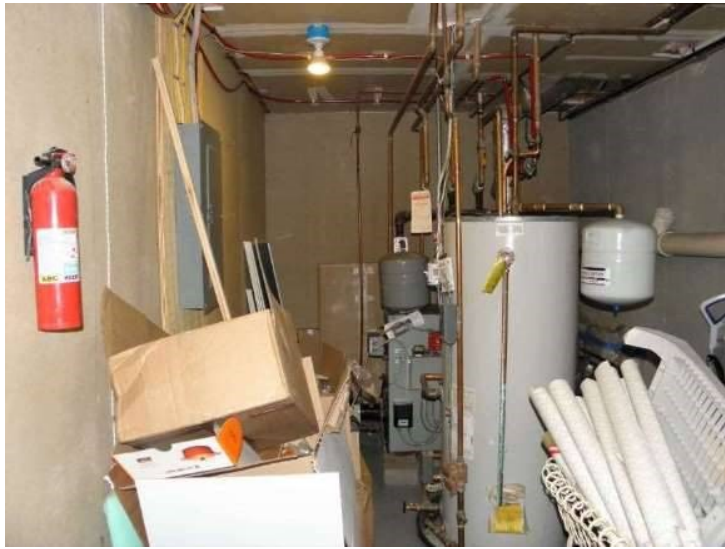
The main service panel cover couldn't be removed due to lack of access from stored items and/or debris. As a result, this panel wasn't fully evaluated. Modifications should be made so that cover can be removed and panel should be fully evaluated by a qualified electrician.

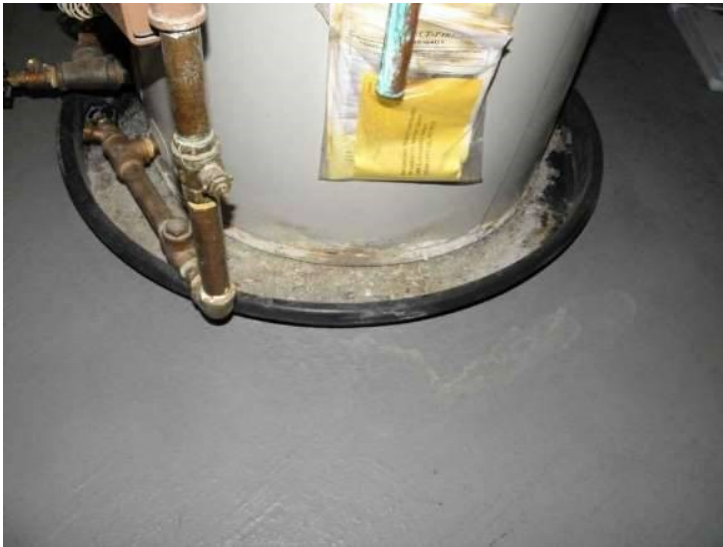
Photo 51-2

The estimated useful life for most water heaters is 8 to 12 years. This water heater appears to be exceeding this age and there is corrosion at the base of the water heater. As a result, this unit may need replacing at any time. Recommend budgeting for a replacement in the near future.

In addition, client should inquire with property owner as to the purpose of the catch pan below hot water heater, as this is not typical for water heaters. Furthermore, there is corrosion and water stains in and around the catch pan, further indicating that the water heater may need replacing in the very near future.

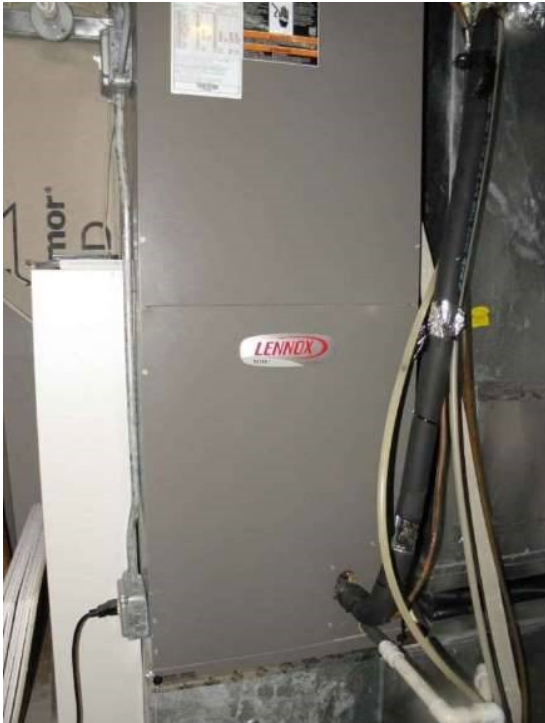
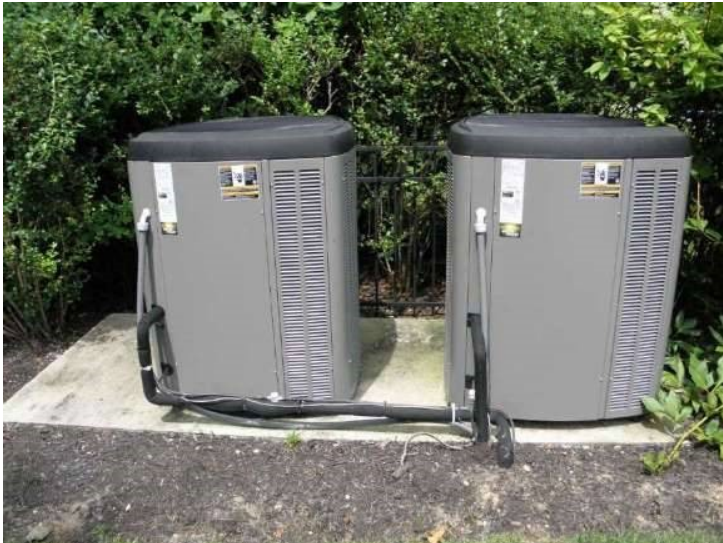
The inspector was unable to determine the last service date as there were no visible service tags. The client should ask the property owner when it was last serviced. If unable to determine the last service date, or if this system was serviced more than two years ago, a qualified heating and cooling contractor should inspect, clean, and service this system and make repairs, if necessary. This servicing should be performed every few years in the future or as per the contractor's recommendations.

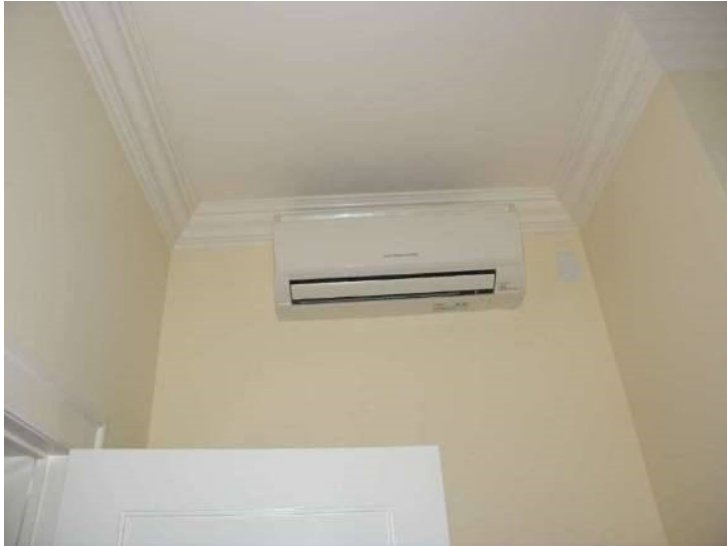
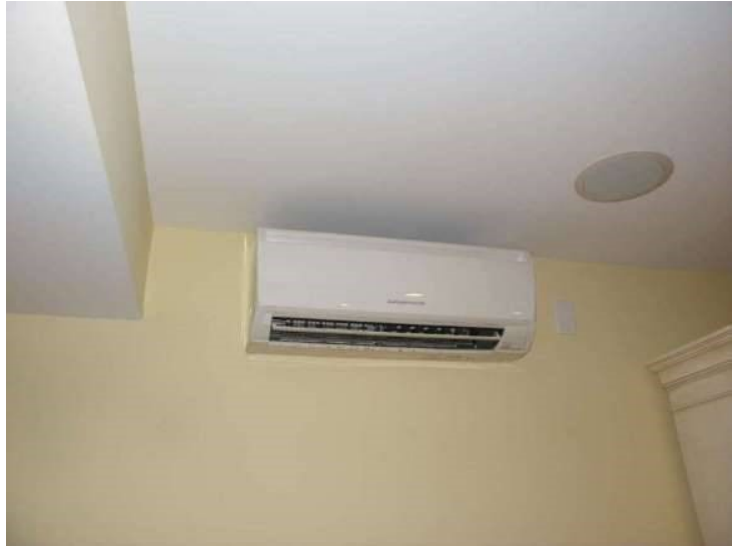
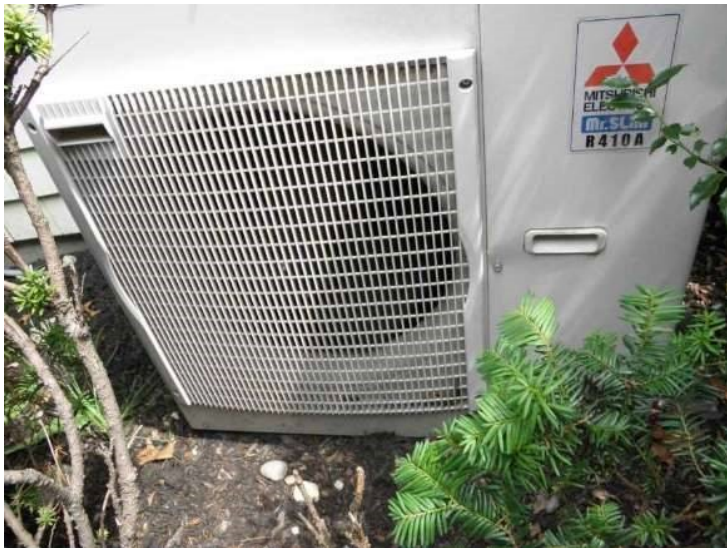
53) ✓ ⓘ It should be noted that the basement and the guest quarters/guest living space is cooled by an independent cooling system. These units also require routine servicing. Client should inquire when these units were last serviced and maintenance was last performed, e.g., filters changed.

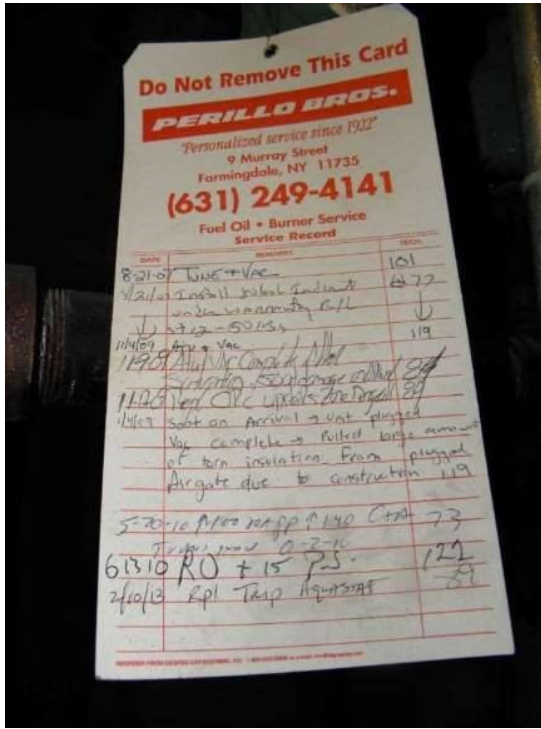
Photo 54-2

54) ✓ ⓘ The boiler appears to be in overall good condition. However, the service tags indicate that unit has not been serviced for more than six (6) years. As a result, unit may not be performing efficiently. Client should have unit serviced now and annually thereafter.

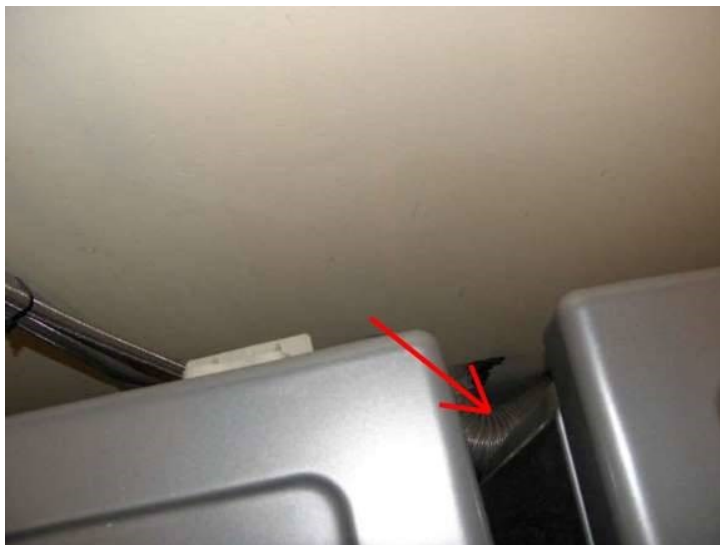
Photo 55-2

55) The clothes dryer is equipped with a foil, accordion-type, flexible exhaust duct. The U.S. Consumer Product Safety Commission considers these types of ducts to be unsafe, and a fire hazard. These types of ducts can trap lint and are susceptible to kinks or crushing, which can greatly reduce the air flow. This duct should be replaced with a rigid or corrugated semi-rigid metal duct, and by a qualified contractor if necessary. Most clothes dryer manufacturers specify the use of a rigid or corrugated semi-rigid metal duct. For more information on dryer safety issues, see <http://www.cpsc.gov/CPSC/PUBS/PUBS/5022.html>

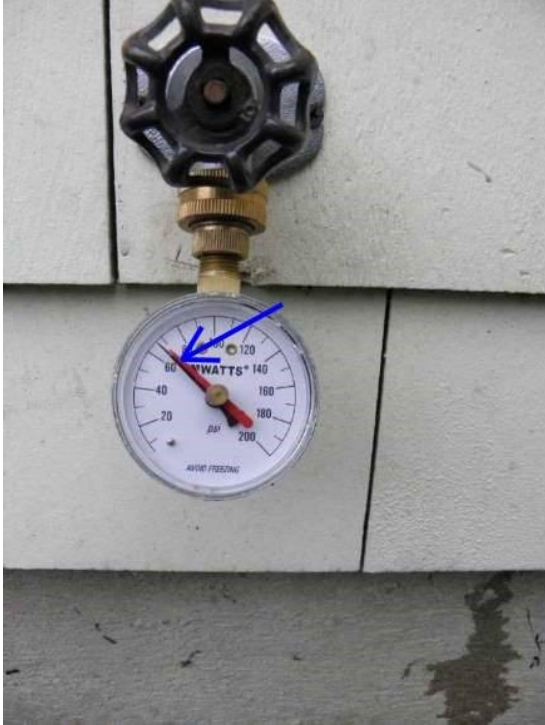
Photo 56-1

56) ⓘ Typical residential water pressure for a home is designed to function under a pressure of 40 to 80 psi. Pressure tested for this home was recorded at 68 psi.

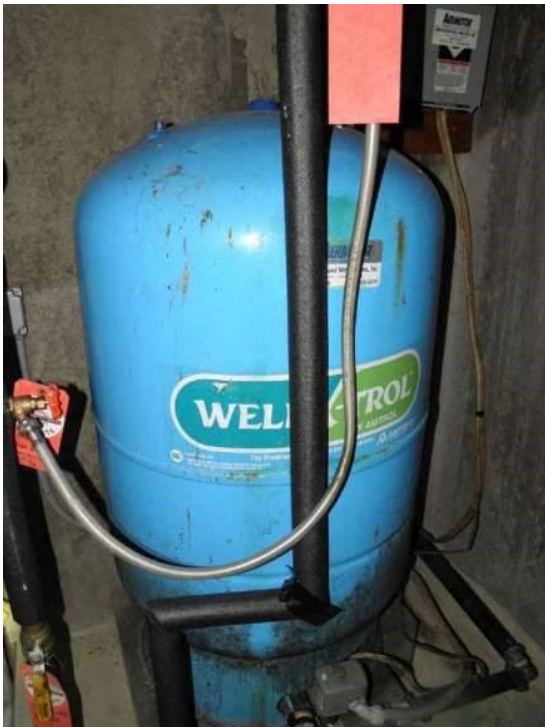
Photo 57-1

57) ⓘ The well is exempt from this inspection and report, however, it is advisable to have the well water tested for coliform bacteria, nitrates and anything else of local concern by a qualified lab. For more information, visit <http://www.wellowner.org>

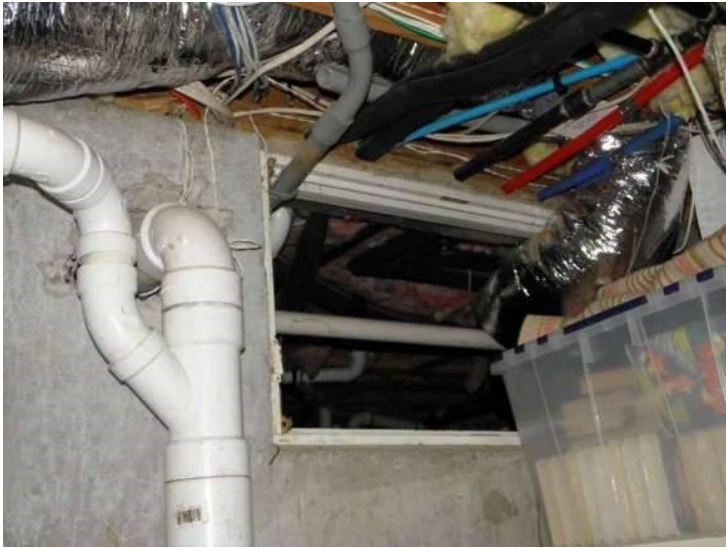
Photo 58-1

The visible crawl space area was inaccessible due to stored items blocking access, limited entry space, as well as obstructing duct work and piping. As a result, this area was not evaluated and is excluded from this inspection and report. Modifications should be made so that this space can be made accessible and area fully evaluated.

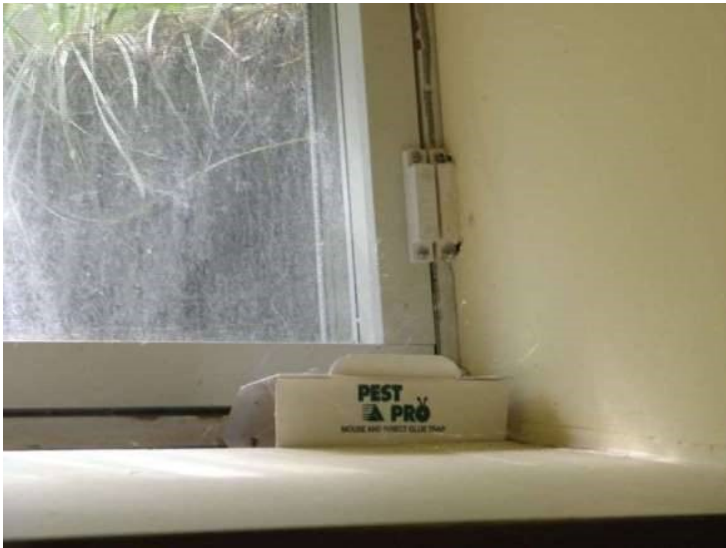
Photo 59-1

Inspector did not find any evidence of rodent infestation, however, rodent infestation may have been previously present as evidenced by a rodent trap. Client may wish to monitor this area for rodent droppings in the future. Rodent infestation may be a safety hazard due to the risk of contracting [Hantavirus Pulmonary Syndrome \(HPS\)](#). HPS is a rare (only 20-50 cases per year in the United States), but deadly (40% mortality rate) disease transmitted by infected rodents through urine, droppings, or saliva. Humans can contract the disease when they breathe in aerosolized virus. For example, from sweeping up rodent droppings.

Client may wish to consult with a qualified, licensed pest control operator to determine if infestation is present.

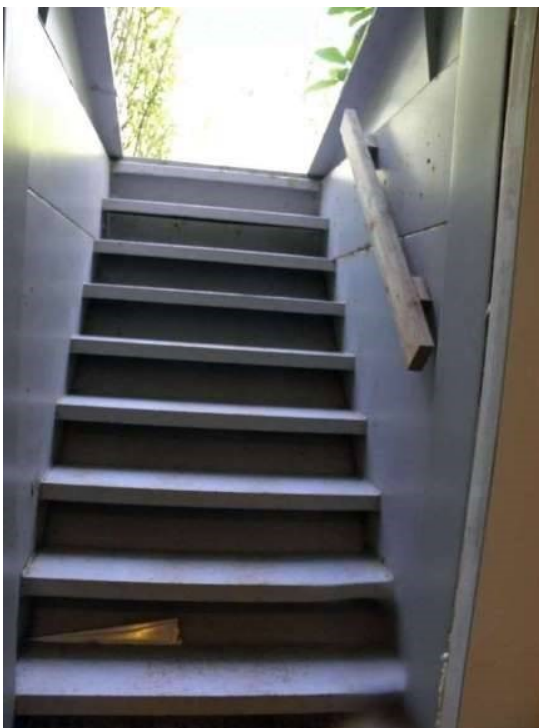
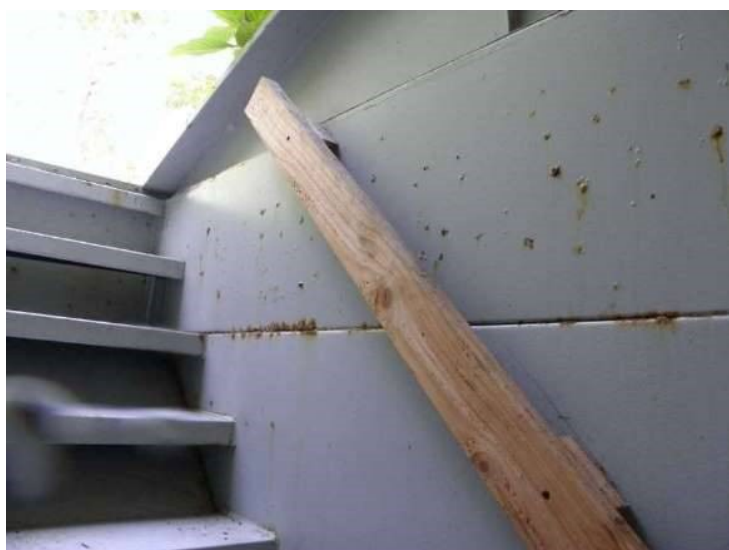
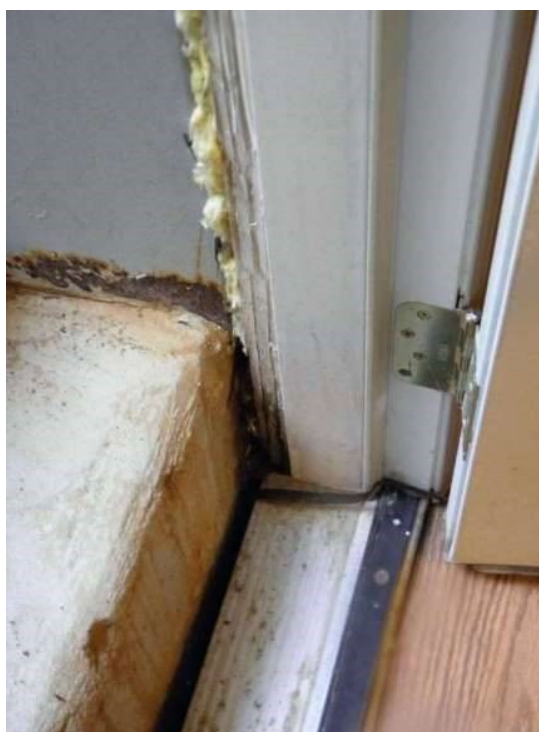
Evidence of prior water intrusion was found in one or more sections of the basement. For example, water stains and/or efflorescence on the foundation and basement entry walls. Accumulated water is a conducive condition for wood destroying insects and organisms and should not be present in the basement. The client should review any disclosure statements available and ask the property owner about past accumulation of water in the basement. The basement should be monitored in the future for accumulated water, especially after heavy and/or prolonged periods of rain. If water is found to accumulate, a qualified contractor who specializes in drainage issues should evaluate and repair as necessary. Typical repairs for preventing water from accumulating in the basement include:

- Repairing, installing or improving rain run-off systems (gutters, downspouts and extensions or drain lines)
- Improving perimeter grading
- Repairing, installing or improving underground footing and/or curtain drains

Ideally, water should not enter the basement, but if water must be controlled after it enters the basement, then typical repairs include installing sump pump(s) or interior perimeter drains.

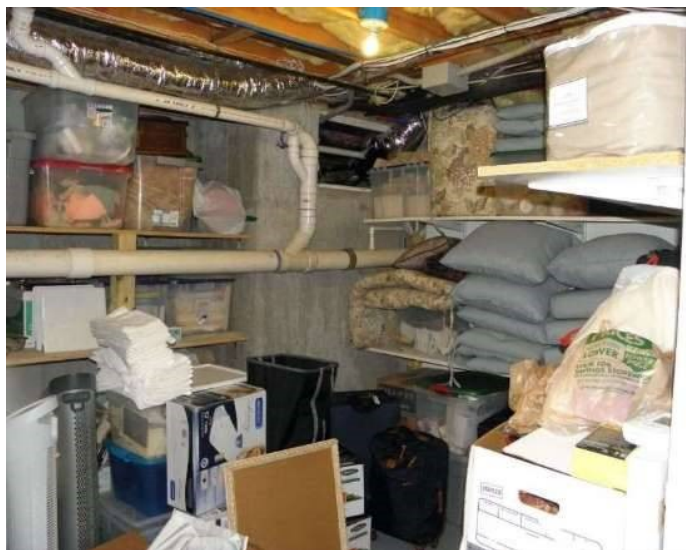
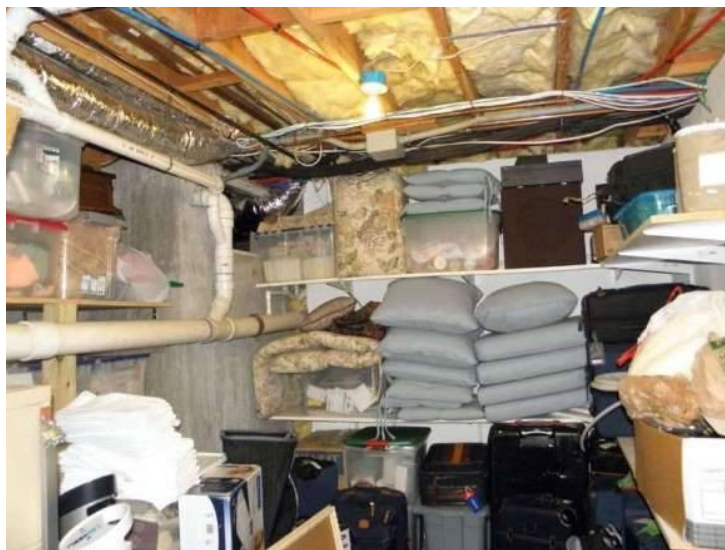
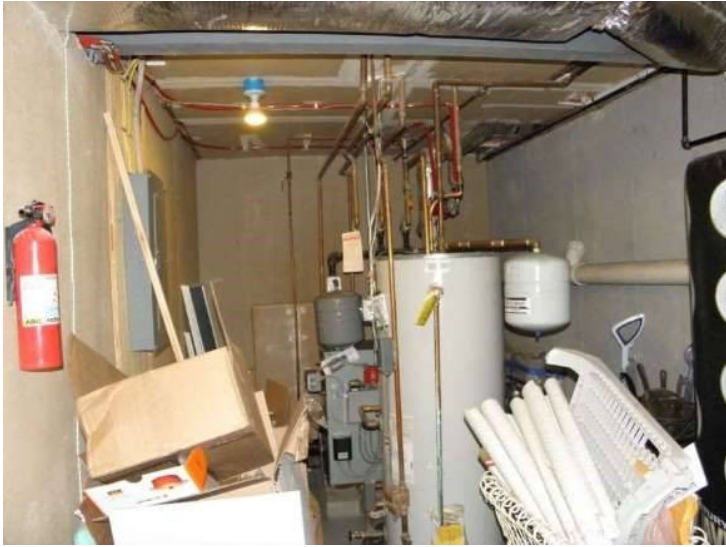
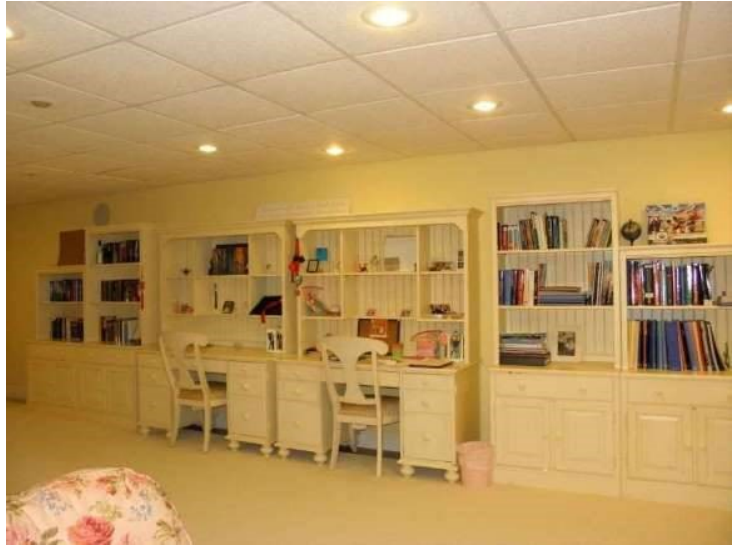
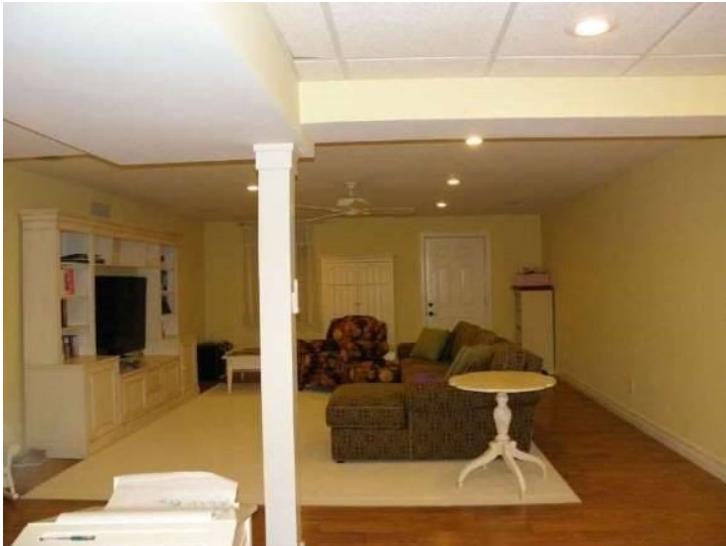
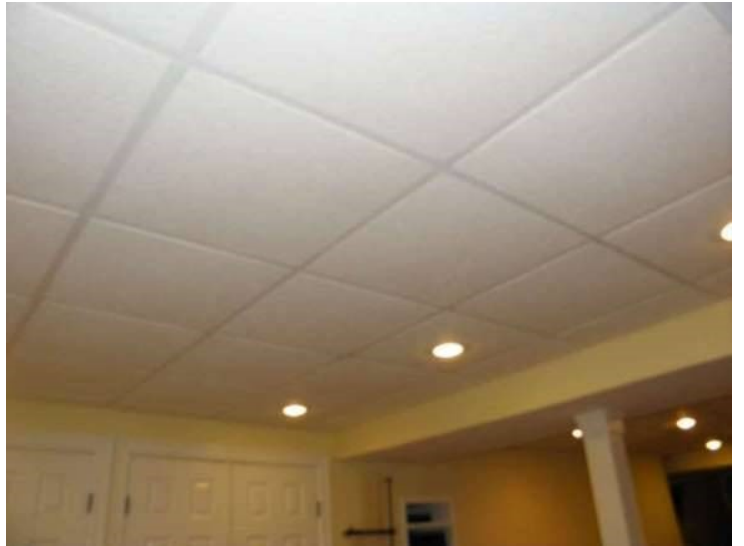
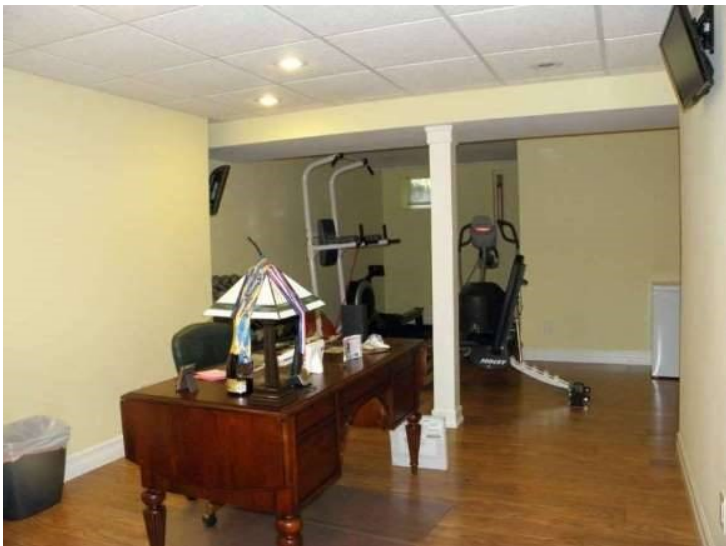
One or more areas of the basement could not be fully evaluated due to excessive stored items, large furniture, and finished ceiling, wall and floor material. As a result, these areas are excluded from this inspection and report.
